Missouri Western State University - Master Plan 2015

Letter From the President

01 EXECUTIVE SUMMARY

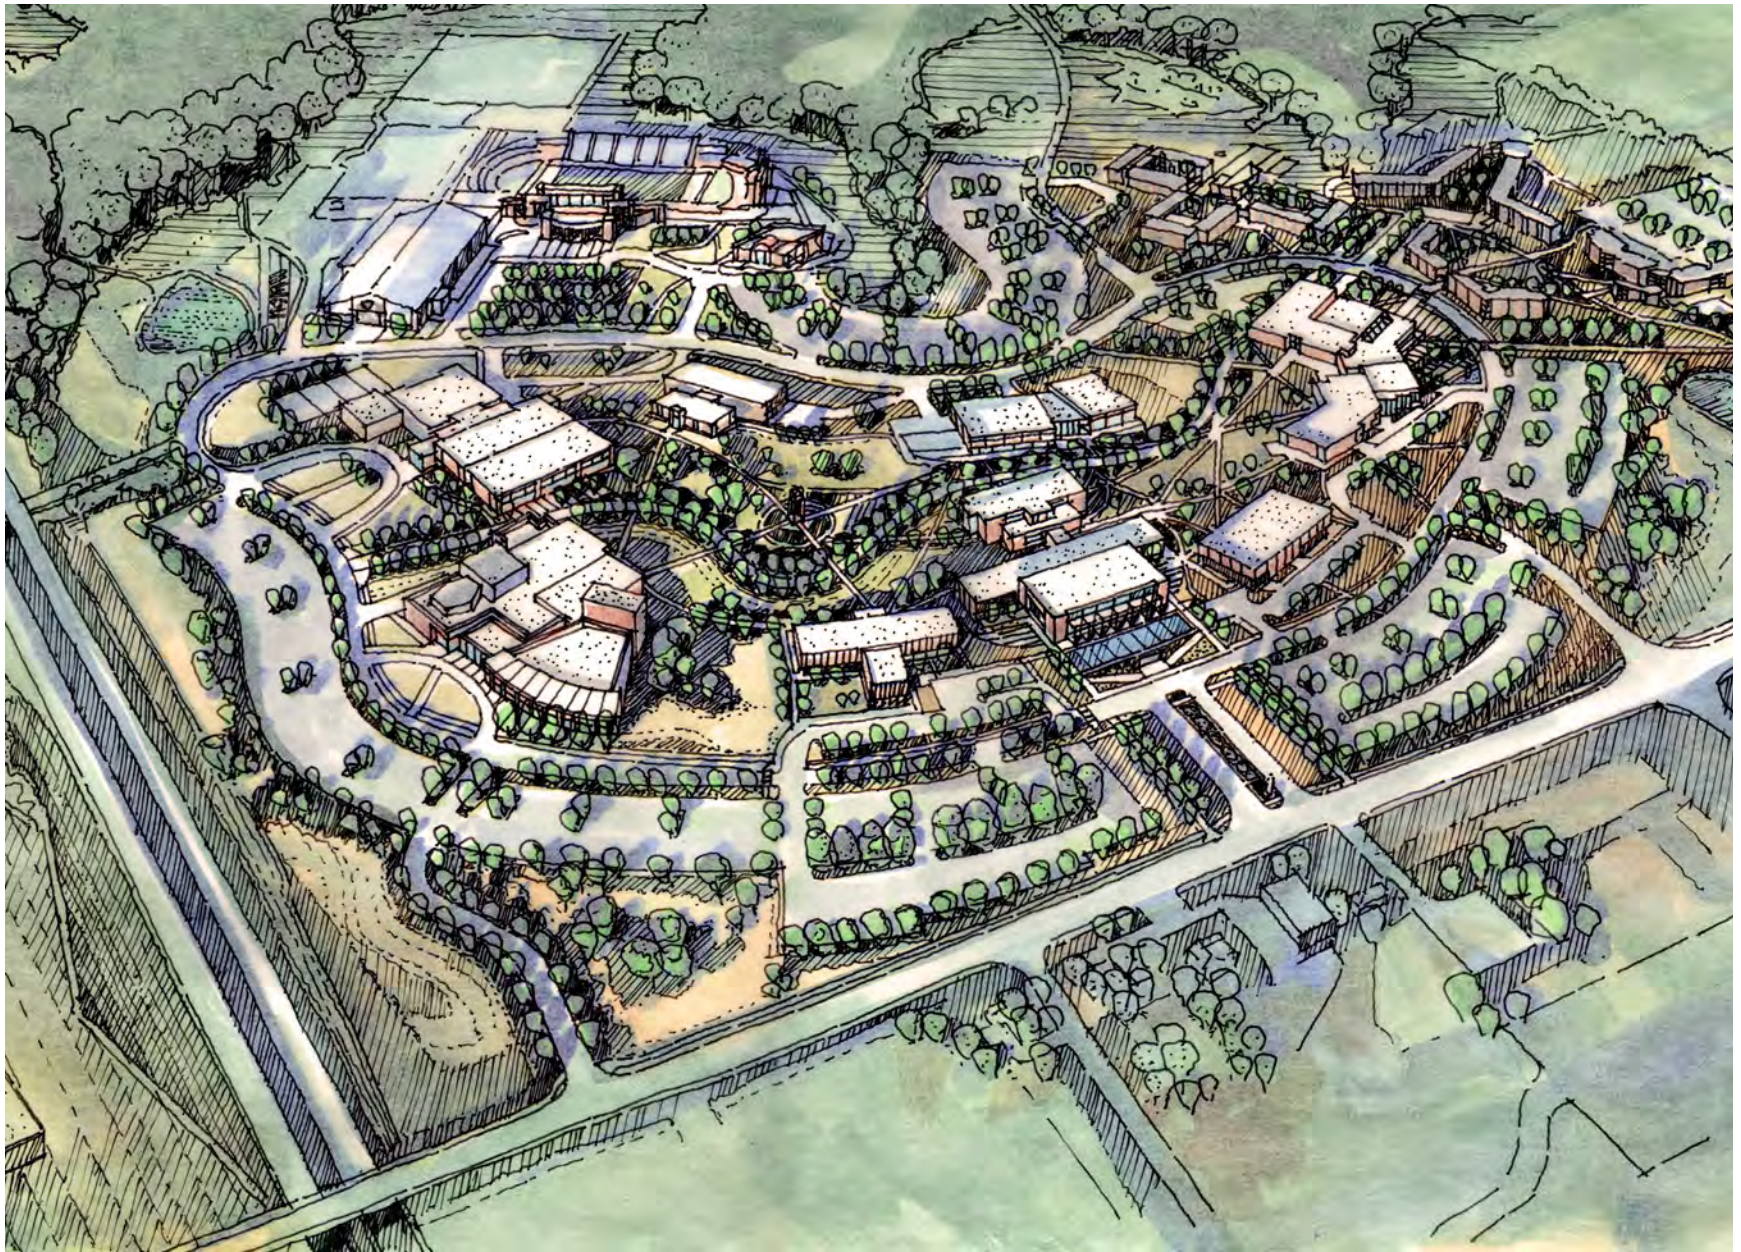
View from the Southwest

The vision for the future Missouri Western University campus honors the foundational layout created in 1967. The 2015 Master Plan capitalizes on the current layout and resources in planning for the next decade of growth of the campus to 7,500 students. The campus design is one of a landscaped park inside a ring road. The academic core sits in a park-like setting on the main ridge of campus and embraces the campus iconic clock tower. A new east-west pedestrian spine connects the campus from the revitalized Potter and Looney halls to the west and the expanded student union and housing district to the east. Quadrangles on rolling hills frame the path of the landscaped spine, improving wayfinding, creating sense of community, and providing a great accessible route for all visitors.

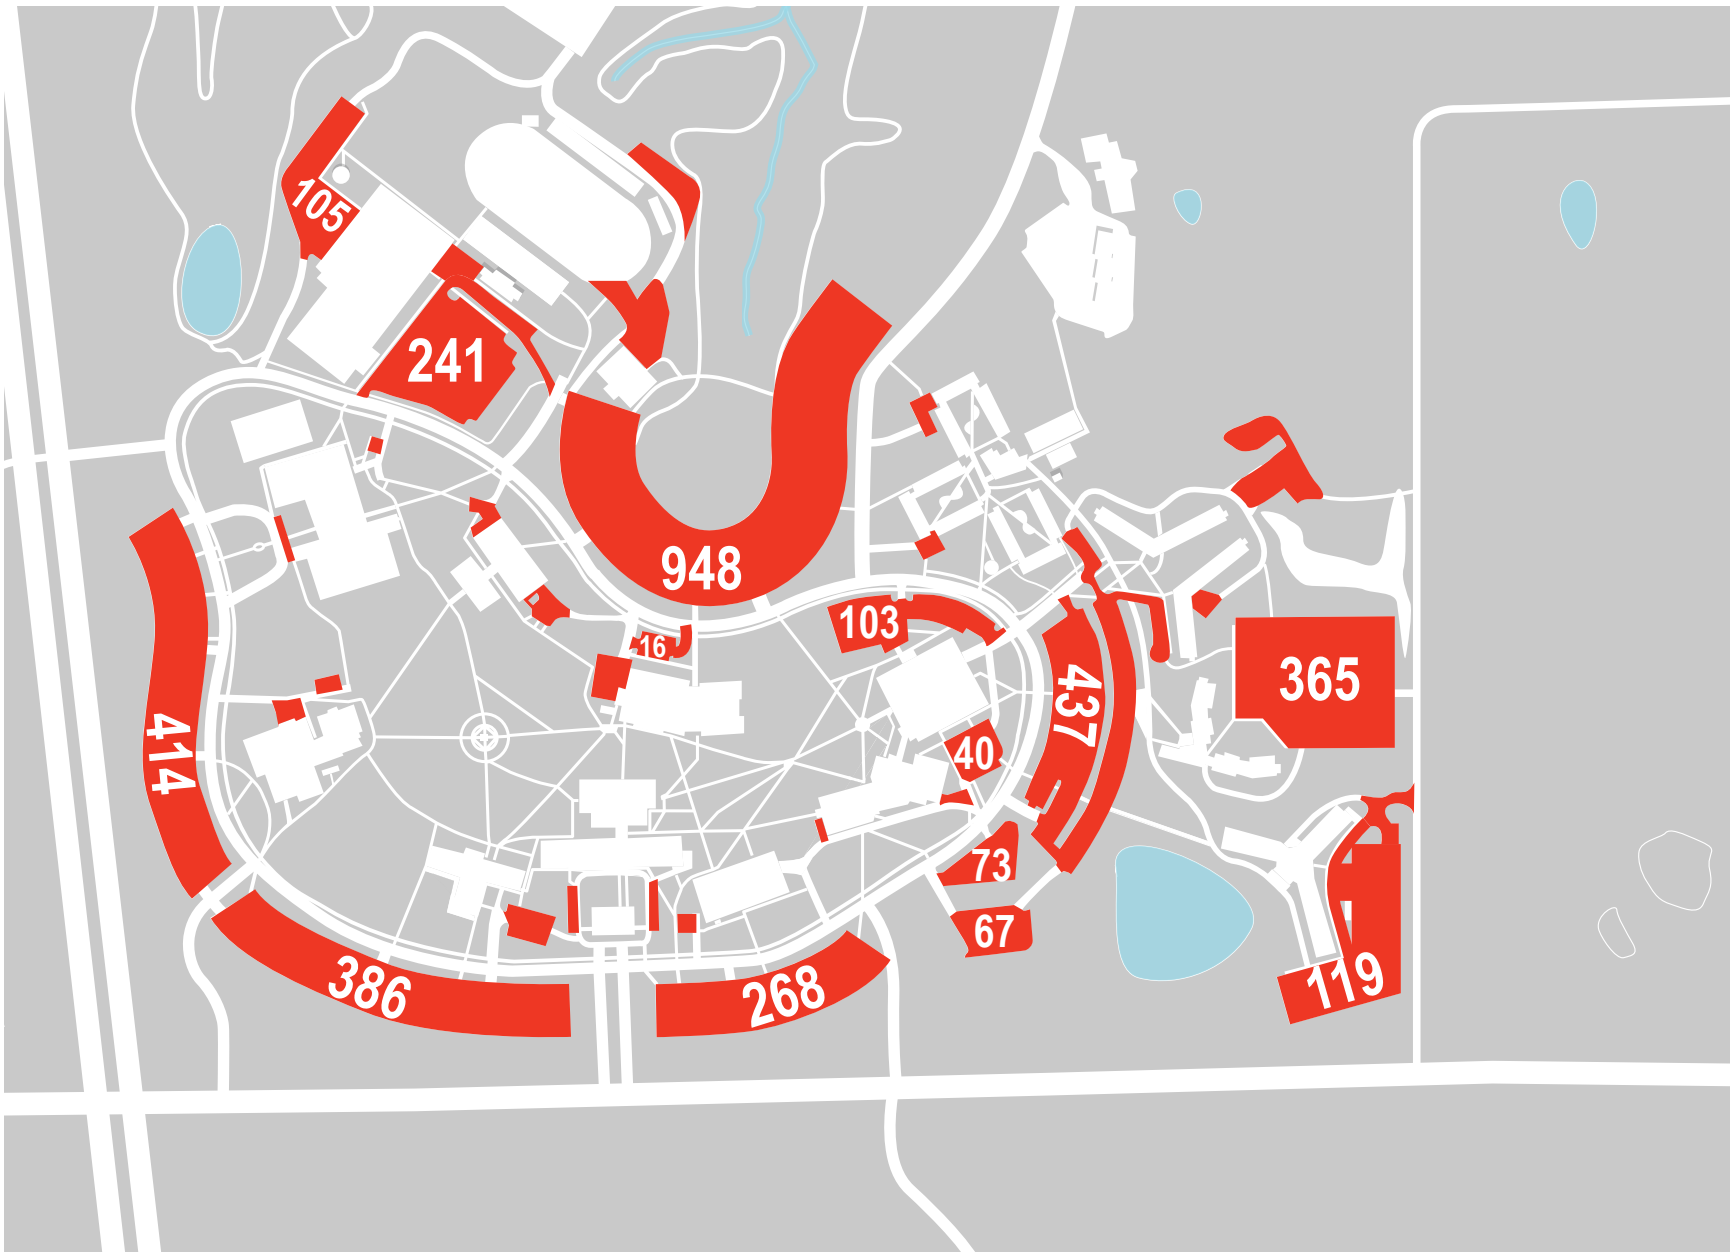
Parking Capacity

Total campus parking capacity exceeds most peer institutions, both in quantity and in spaces per enrolled student. Analysis and observations reveal that some lots are full to capacity, while the overall usage campuswide is only 68% full at the peak. Distribution of parking spaces does not currently align with the demand in the vicinity of Eder and Popplewell halls (*diagram on page 36*).

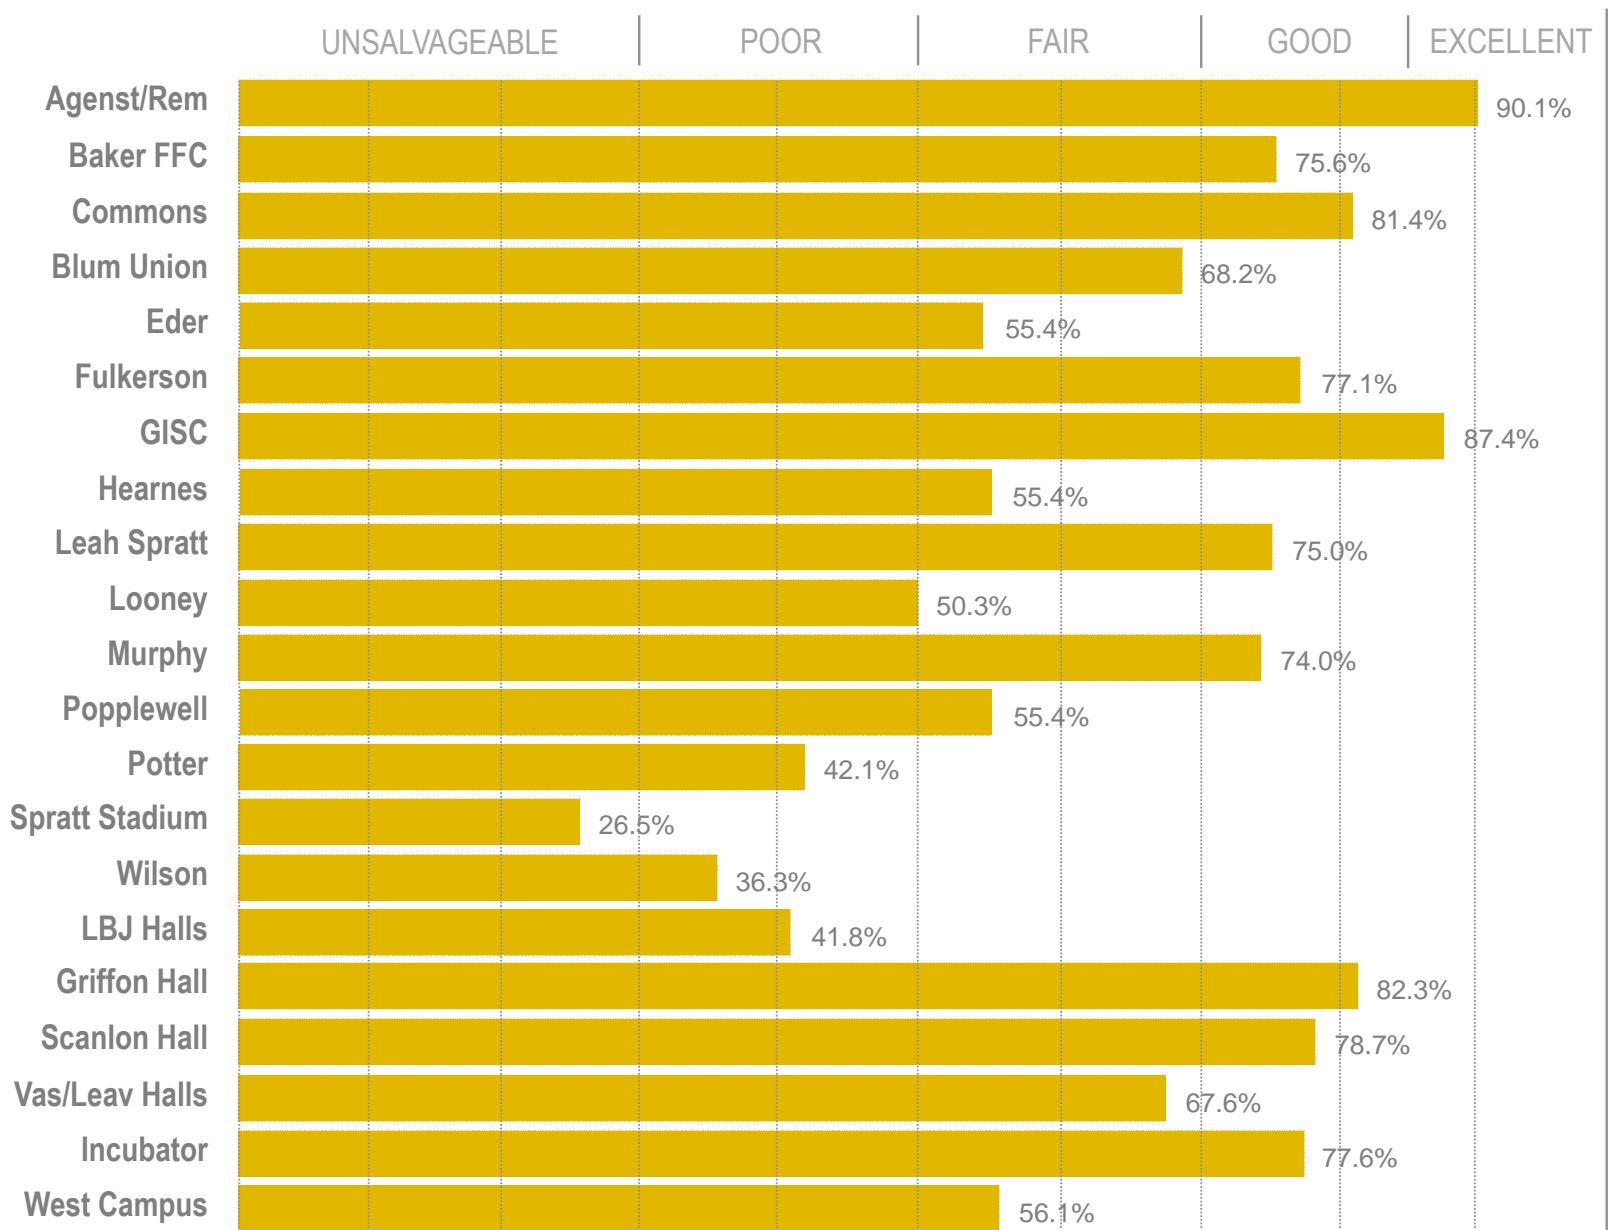
Campus: Building Component Analysis

A comprehensive building condition review of each primary building on campus was conducted. This section includes a summary table showing all buildings. The Appendix of this document contains a component analysis for each building. A building component analysis describes each building's condition in representative numeric values.

Each item's condition is evaluated and given a ranking from excellent to unsalvageable. Excellent systems are new or near new as a result of recent installation, repair and/or replacement. Good means no obvious deficiencies in condition or performance, and serviceable with basic maintenance. Fair indicates a need for minor repair and limited replacement of components based on age and/or performance. Poor means failure of primary components and multiple systems is evident, and major repair or replacement is required. Unsalvageable means the components or systems are unusable, code deficient and/or not suited for current use and complete replacement is necessary.

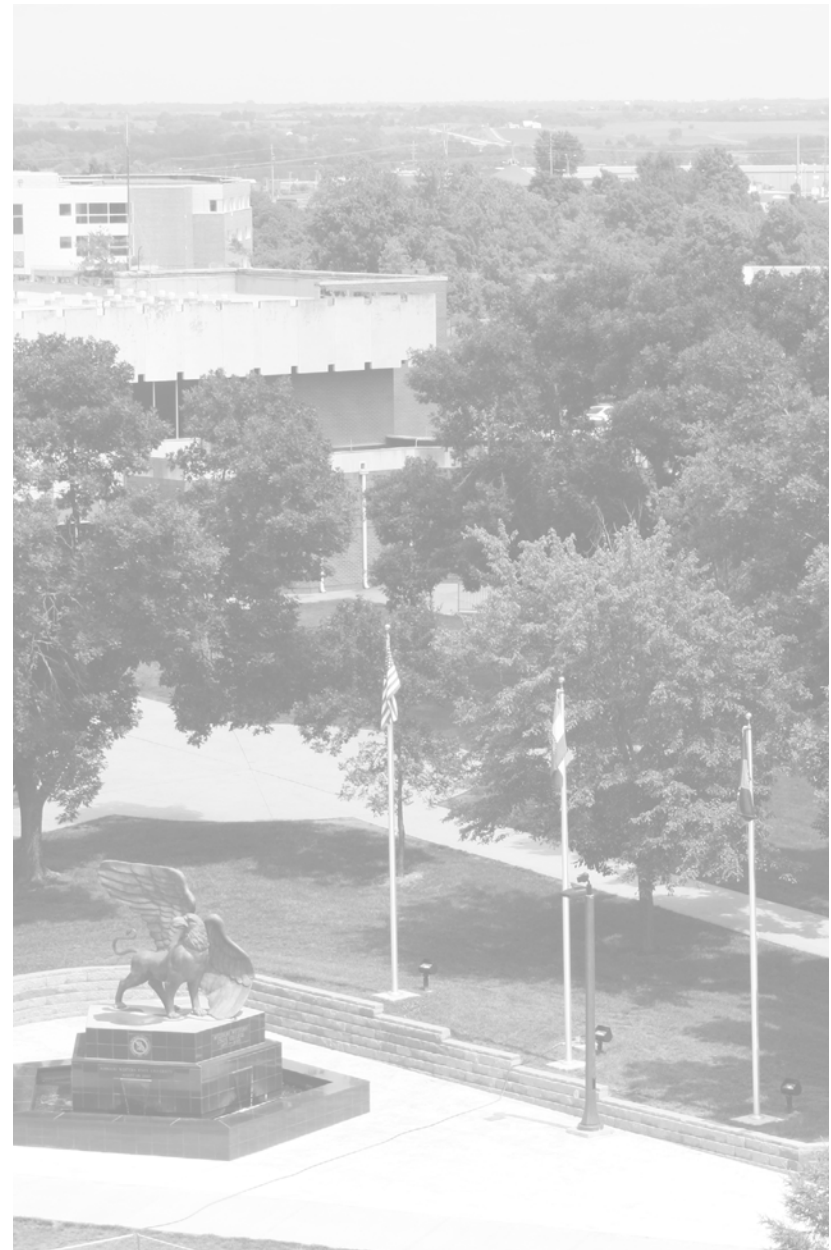
CLASSROOM HOURS PER WEEK
BY CLASSROOM

This analysis looks at department, building and campuswide utilization for classrooms. Utilization is assessed for both seats filled as a fraction of the course capacity, as well as seats filled as a fraction of the total seats available. All buildings when averaged together are slightly underutilized relative to current capacities.

The average student station occupancy or percentage of seats filled when classrooms were in use averaged 54.3%. This compares to national guidelines for public universities of 60-70%.

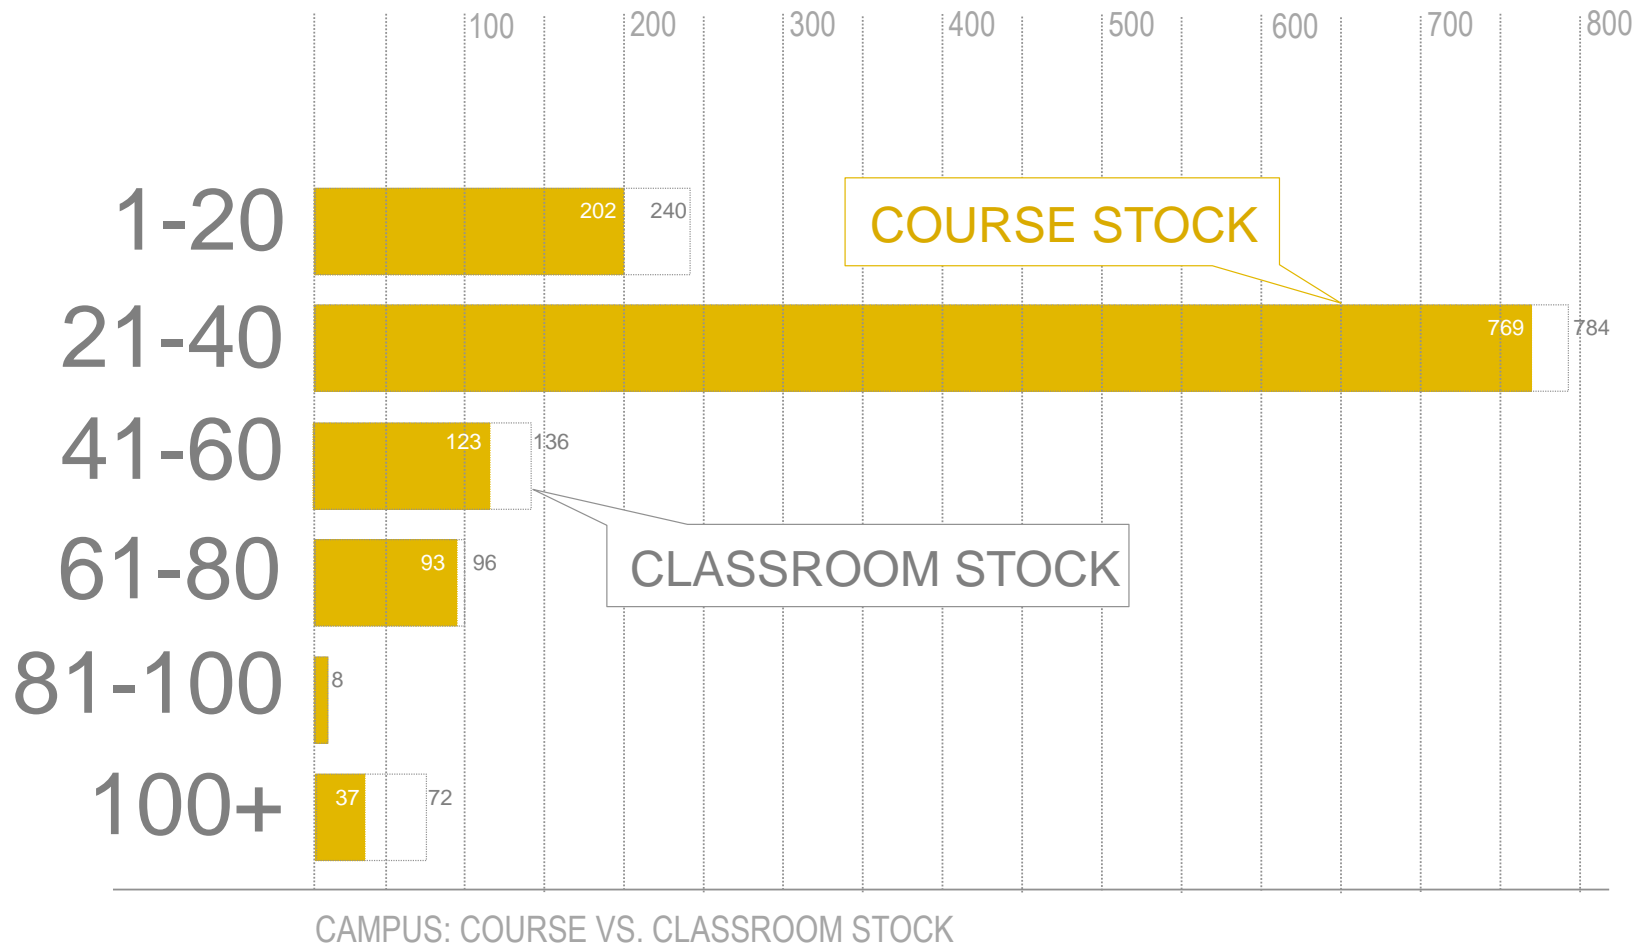
Classroom Availability

The analysis above looks at course demand vs. classroom supply. For simplicity, classroom supply has been reduced to (6) groups, classrooms having 1-20, 21-40, 41-60, 61-80, 81-100 and 100+ available seats. The results of this exercise indicate that for all classroom sizes supply is slightly

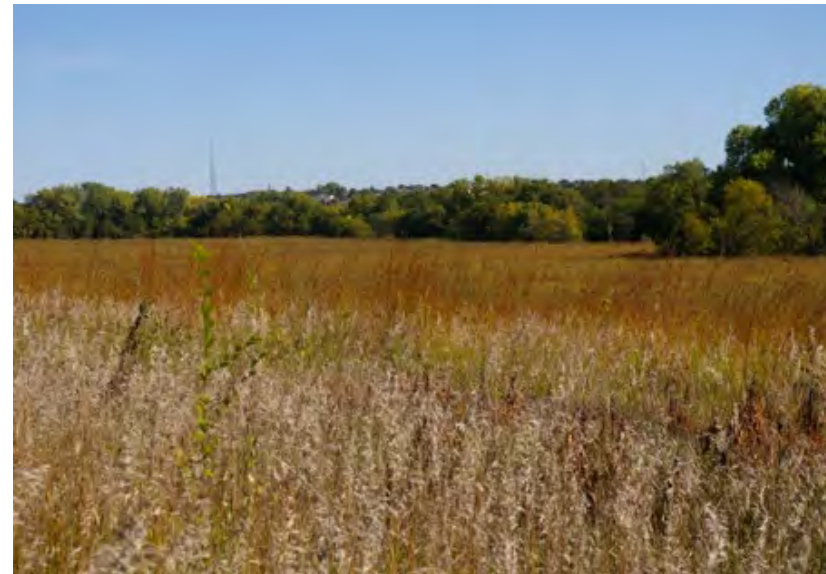
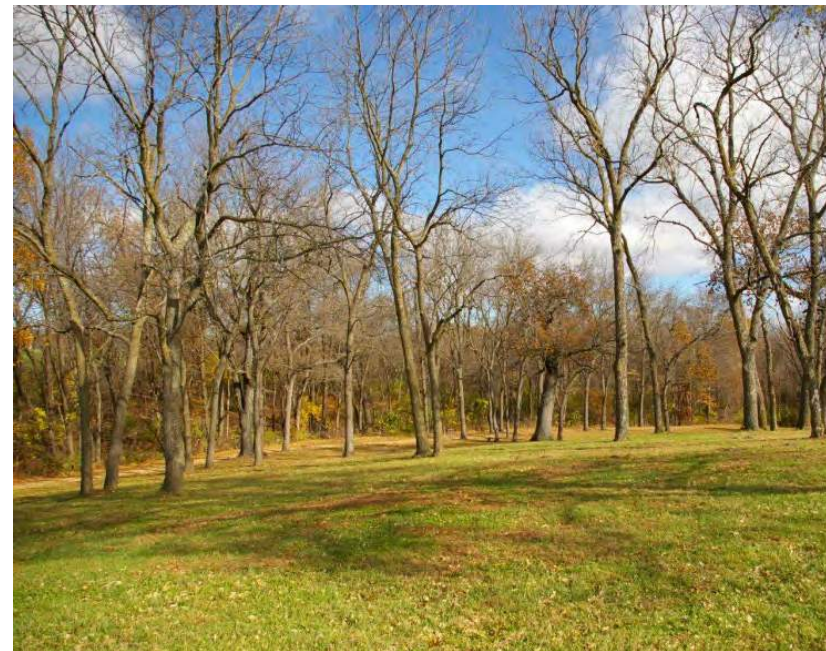
Area North of Spratt Stadium

Pastoral / Savanna: These areas are primarily near the stadium, north of the Downs Drive loop road, and consist of grasslands with shade trees spotted throughout.

Treatment: With the exception of reduced mowing, the areas should remain mostly unchanged. Additional trees may be planted.

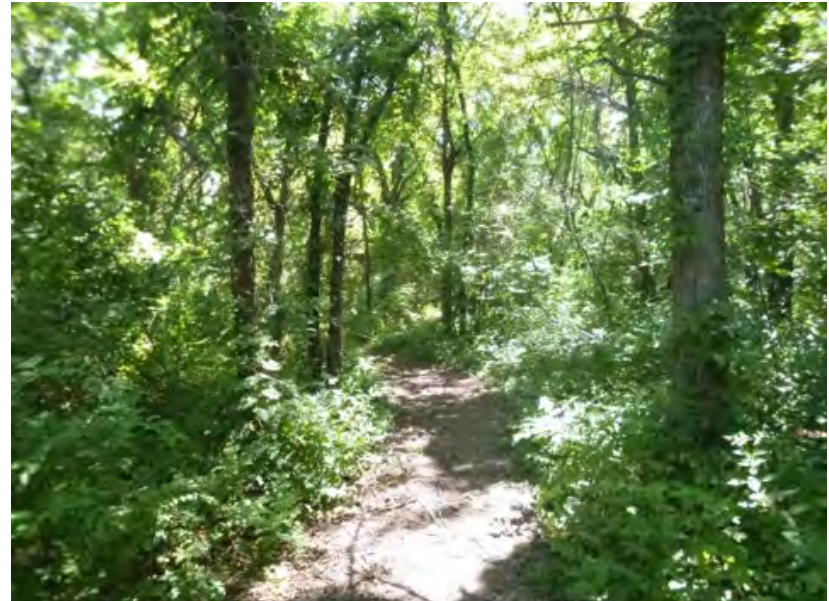
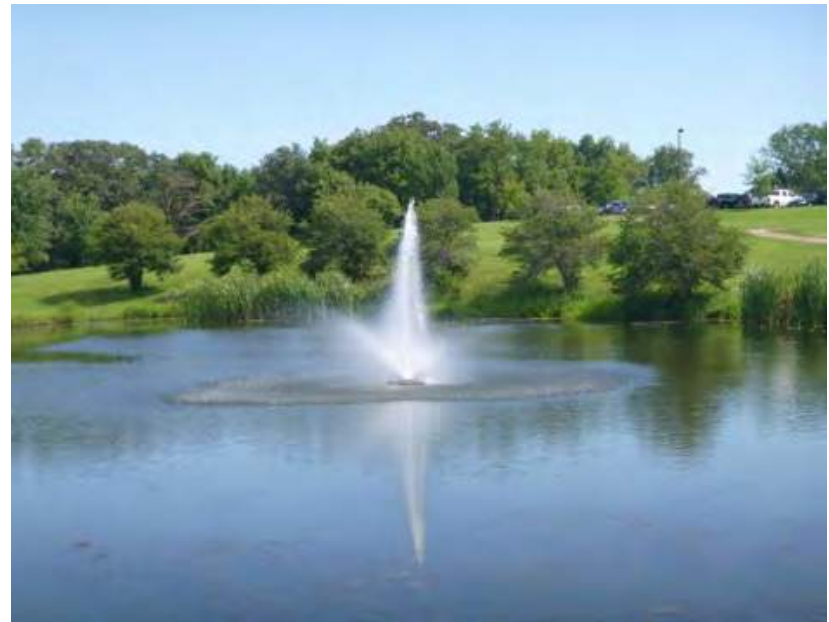
Pond West of Spratt Stadium

Pond: 9 ponds of varying size and quality are located on campus and used for stormwater control, research, lab exercises and aesthetics.

Treatment: A minimum 25-foot grassed buffer (preferably native grasses) should be implemented at the perimeter of each pond to provide protection from adjacent impacts, filter stormwater run-off, and to act as a deterrent for the resident Canada goose population. Long-term management of the ponds should include creation and/or planting of a wetland bench within the inner edge (littoral) of the pond perimeter. The wetland bench should be 5 to 10 feet in width with a variety of wetland plant species. The wetland bench will assist with filtration of sediment and pollutants from stormwater runoff, eliminate bank erosion due to wave action, deter resident geese, and provide habitat for wildlife. Enhancement of the shoreline will also provide an aesthetic amenity for the students and public.

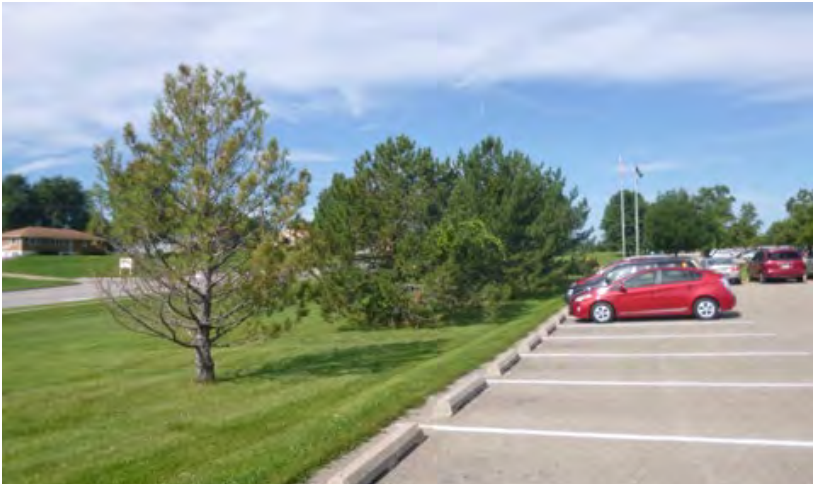
Parking Lot Along Mitchell Avenue

Parking and Support: Areas used for vehicular parking and movement and for campus maintenance areas.

Treatment: Shade trees and green space should be added to large paved areas to reduce urban heat islands and improve aesthetics. Support areas, at a minimum, should include groundcovers to prevent soil loss.

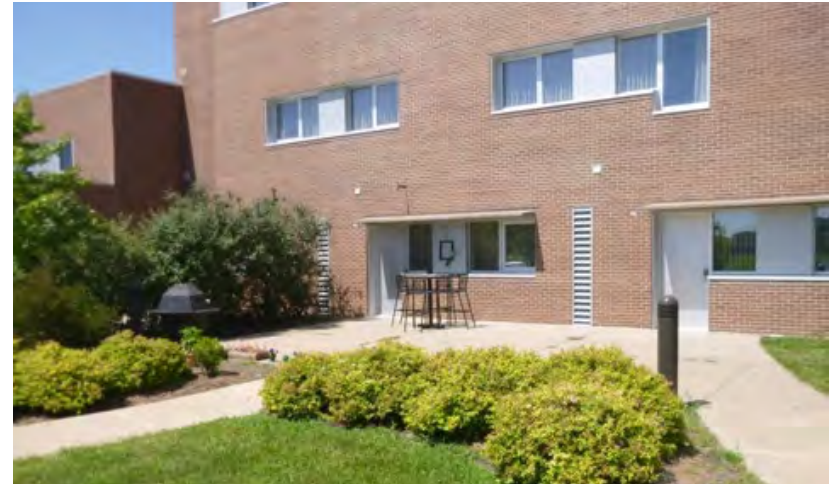
South Side of Scanlon Hall

Housing: Areas around student housing that act as residential “yards” and convey the vision of “Midwestern Comfort.”

Treatment: These areas should include manicured lawns, shade trees and accent plantings (shrubs, ornamentals and groundcovers) at building entries.

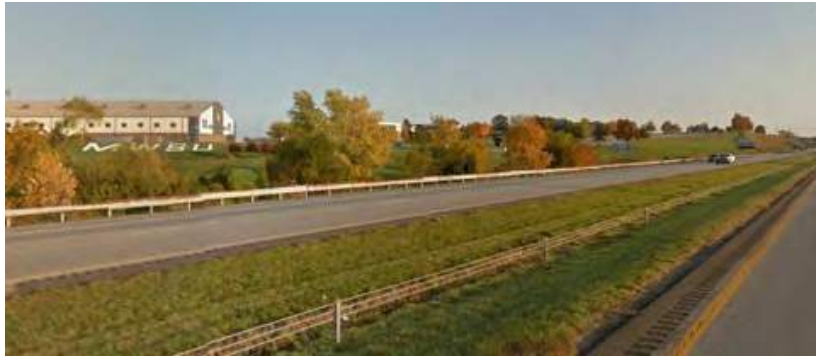
Looking Southeast from I-29

Visible Edge: Areas adjacent to I-29 where the campus is visible from people passing by and the Missouri Western brand can begin to be presented.

Treatment: These areas should remain primarily open, allowing views into campus from fast-moving vehicles. Views may be framed by deciduous trees.

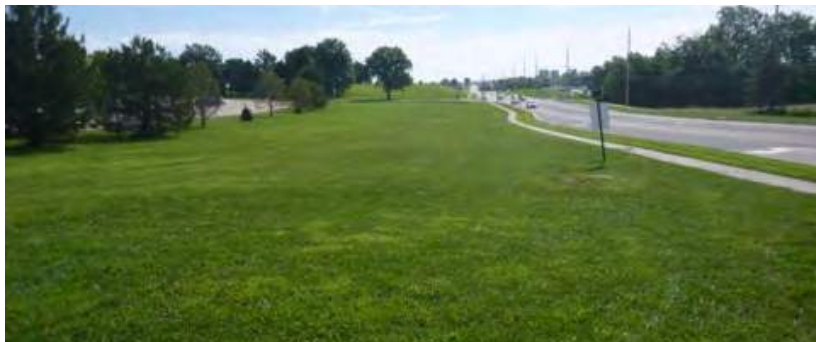
Looking East Along Mitchell Avenue

Identity Edge: Areas along Mitchell Avenue and Faraon Street that are directly adjacent to campus where campus features can begin to be identified.

Treatment: These edges should consist of well-manicured turf and can be moderately planted with trees allowing filtered views to parking areas and buildings. Accent plantings such as shrubs and ornamentals should be used to highlight entry points and signage.

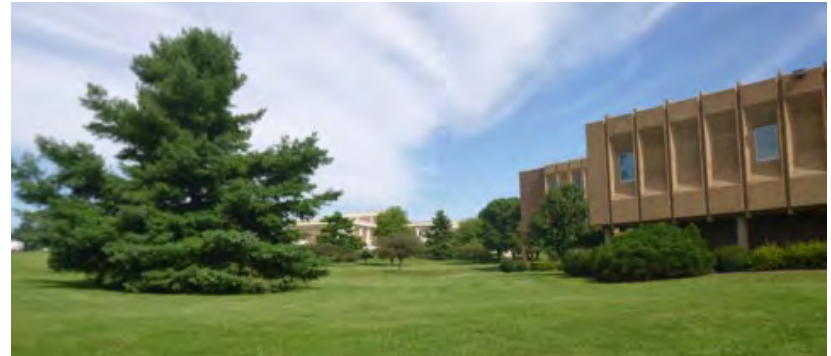
Looking Northwest at Popplewell Hall

Campus Core Edge: Areas within the loop road, Downs Drive, that allow views into the campus core where buildings and other destinations can be clearly identified.

Treatment: Landscaping in these areas should begin to introduce pedestrian scale plant materials such as shrubs and reinforce academic landscapes.

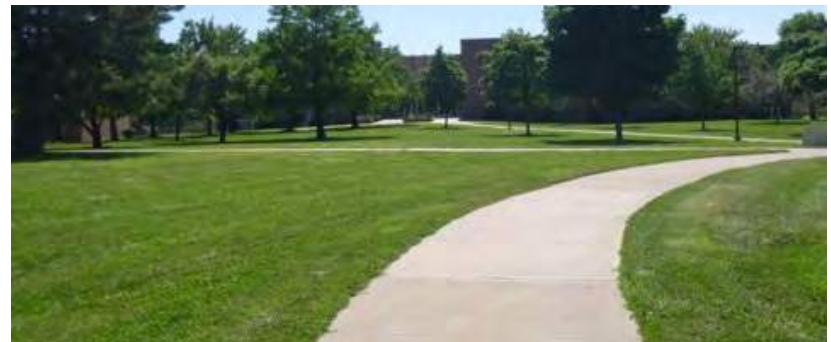
Within Green Spine

Green Spine: Area located within and bound by academic buildings used for the circulation of students to classes. This area also includes the clock tower.

Treatment: This area should consist of shade trees and well-manicured turf. Accent plantings may be used at selective locations such as the clock tower and university plaza.
