# Missouri Western State University - Master Plan 2015

## 01 EXECUTIVE SUMMARY

# MASTER PLAN DESCRIPTION

## 02 ANALYSIS

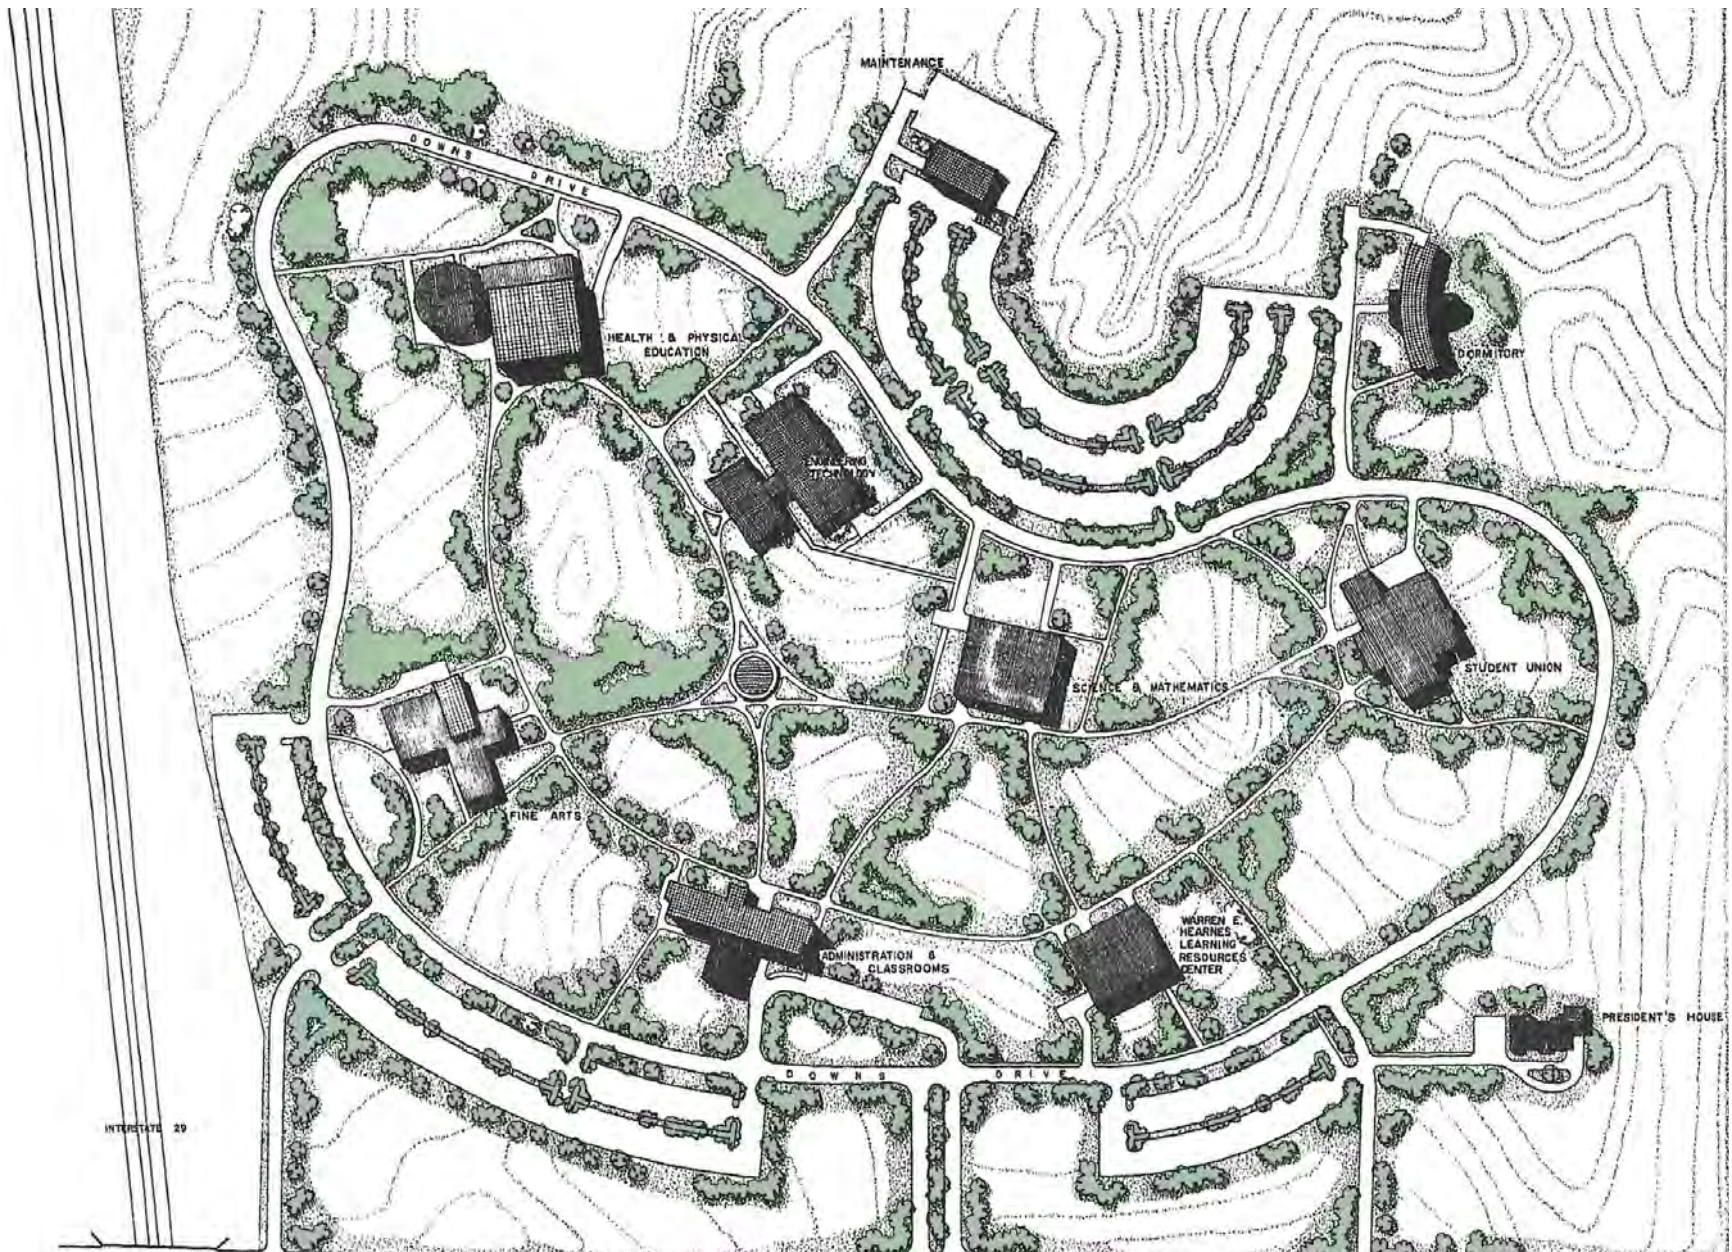
Original Master Plan

1967 was the year that planners and architects created the foundational layout and design for the Missouri Western State University campus of today. Three hundred ninety acres of rolling farm and timberland were planned for the relocation of 1,000 students attending Missouri Western Junior College in downtown St. Joseph. This new campus would allow the college to evolve into a full four-year institution offering baccalaureate degrees, and the initial construction would provide for growth to 3,000 students. The design specifically anticipated an eventual and orderly expansion to 15,000 full-time students.

for the eastern ridge. Large parking lots provided convenient vehicular access for this largely commuter student body. Uniformity of buildings was encouraged through the use of exposed concrete and masonry. The developed ridges were landscaped as open lawns. Creeks and ponds were left undeveloped as wooded areas.

Notably, the initial space between buildings was designed for the maximum distance still allowing for reasonable class change times. This was a purposeful design feature made to provide for periodic expansions of each building without altering the basic overall plan.

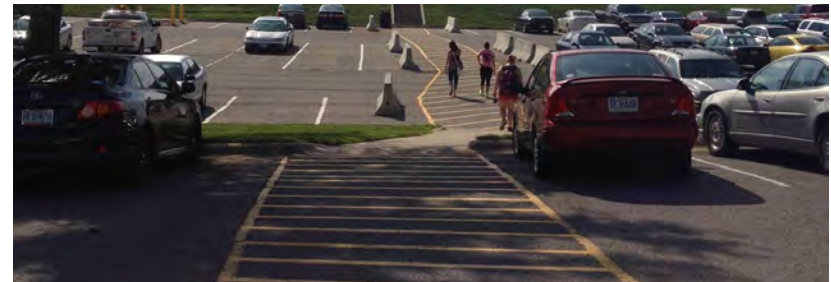
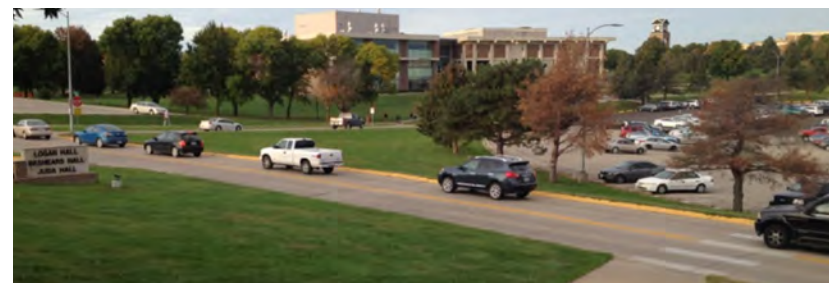
Photo Documentation On-site

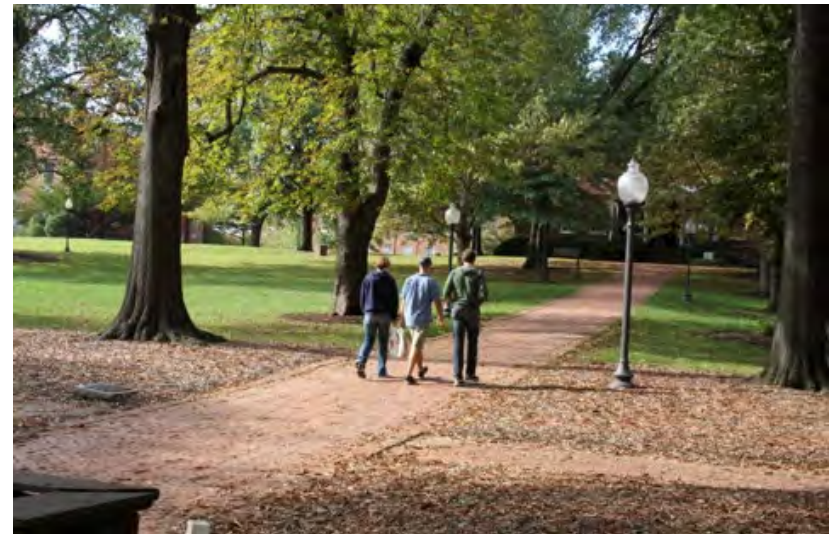
**Pedestrian Concourse:** The pedestrian concourse is the primary path through campus conveying high volumes of traffic and also acts as a fire lane. Although serving a functional purpose, the concourse should not detract from the aesthetic of the green spine.

Treatment: The pedestrian concourse should feature a clearly defined walkway, shade trees providing a respite from sun or rain, and site furnishing amenities. If feasible, the walkway should be constructed or accented with specialty pavements.

Example of Pedestrian Concourse

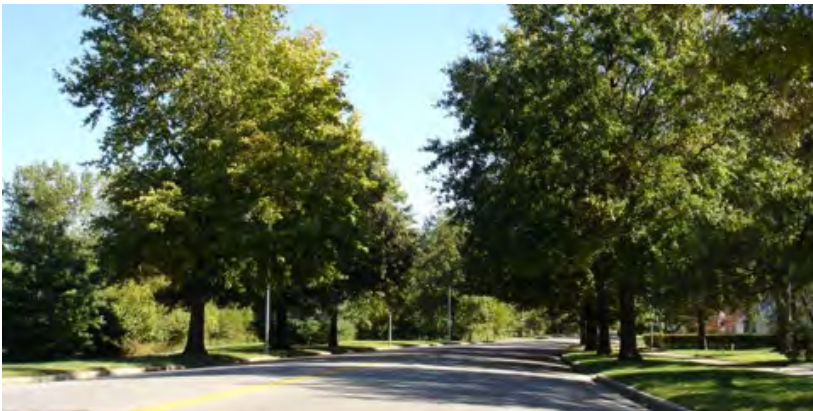
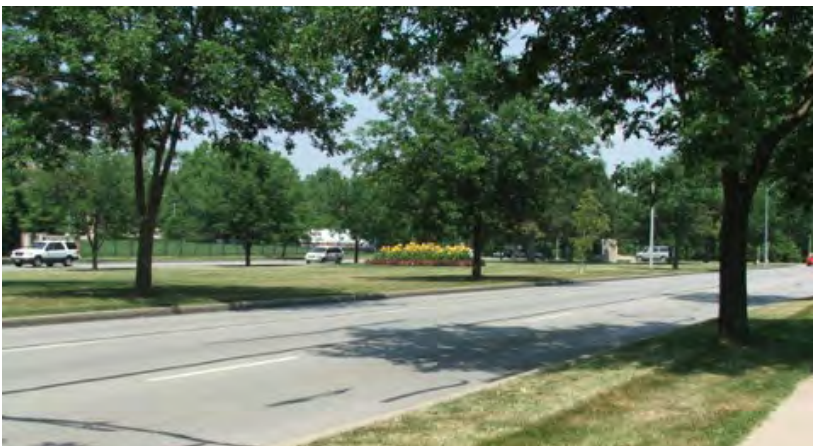
**Street Trees:** Street trees along the south and west portions of Downs Drive. Additional trees, consisting of new plantings and/or replacement plantings, should be planted along Downs Drive and James McCarthy Drive to reduce the heat island effect, calm traffic and enhance motorists experience.

Treatment: Plant street tree species along both sides of Downs Drive on a formal spacing. Species shall be native and/or adapted to the region, low-maintenance, and ascending in habit to avoid damage from large vehicles.

Example of Street Trees

**4. Plant Street Trees:** Replace dying Ash species and plant new street trees along the entirety of Downs Drive to improve aesthetics, provide shade and reduce heat islands, and calm traffic. Refer to the Landscape Master Plan.

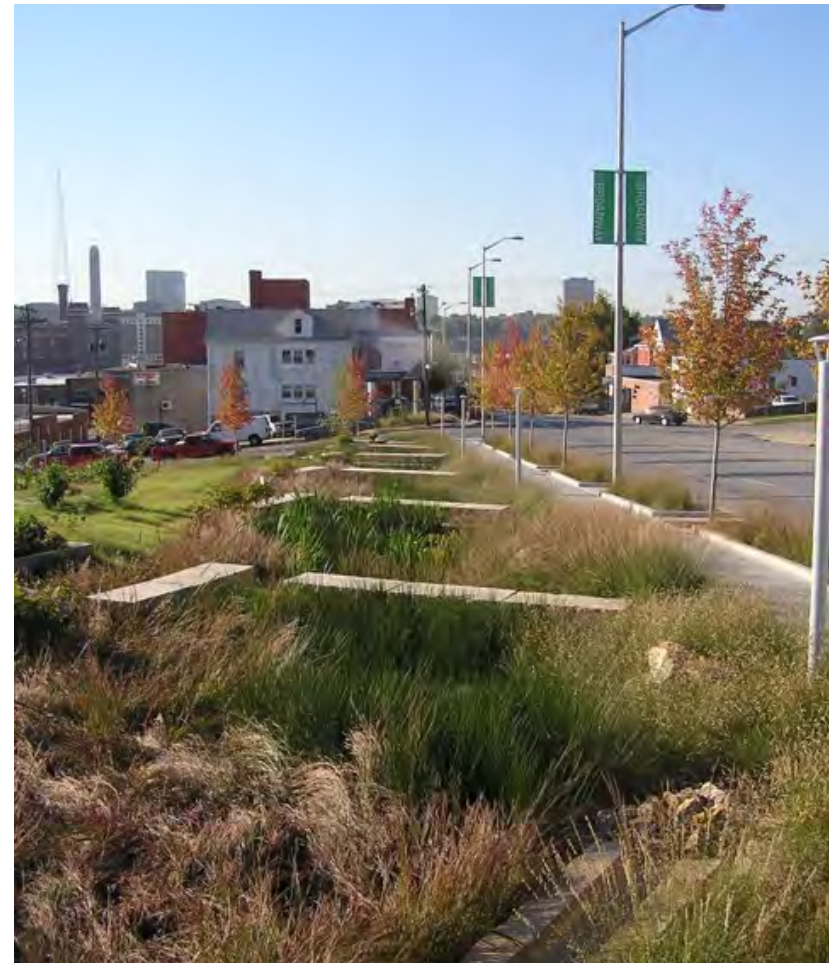
Example of Vegetated Swale and Ledgerock Weirs  
(18th & Broadway, Kansas City)

**Stormwater Best Management Practices (bmp's):** Various bmp's throughout campus that capture stormwater and reduce erosion and soil loss. Rather, this stormwater can be used to water plants, with excess infiltrating on site.

Treatment: Install bmp's such as rain gardens, bioretention basins, detention facilities and pervious pavements wherever stormwater is collecting and erosion taking place.

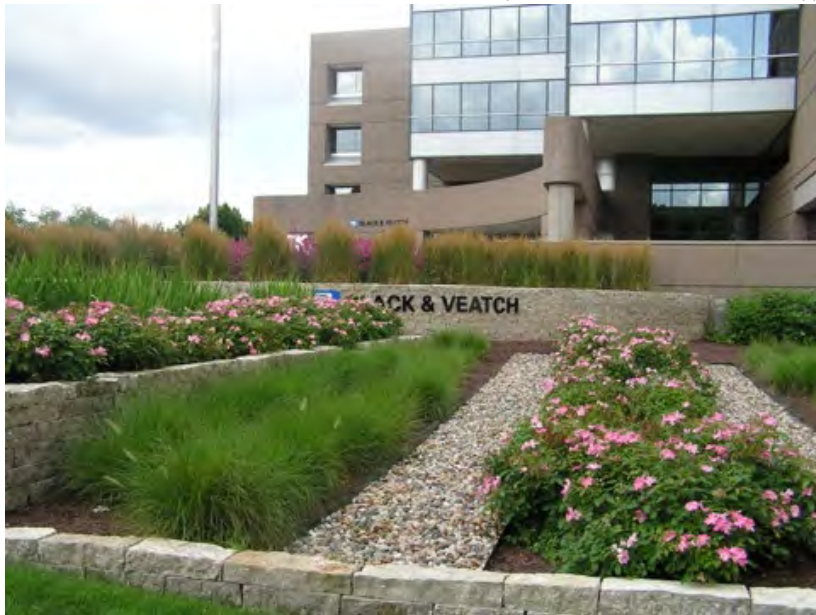
Example of Bioswales

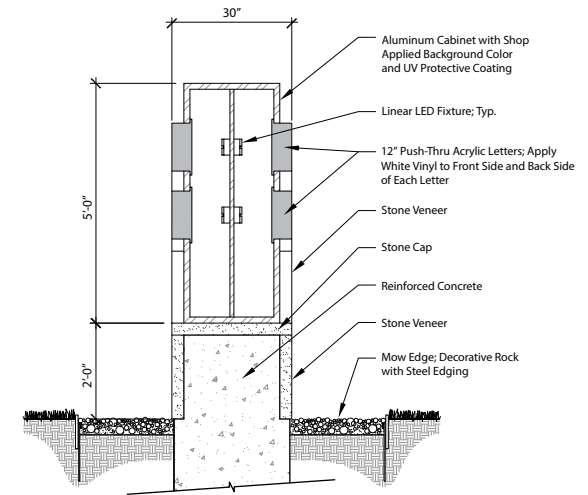
**Main Entry**  
Section

The team studied the vehicular arrival sequence, pedestrian flow, and the location and condition of existing signage, and proposed a comprehensive signage system including campus identity signs, vehicular wayfinding signs and facility identity signs. The result of this system is improved unity, regulation, simplified wayfinding in the form of a clear progression of signage. While no overhaul of the current signage system is possible at this time, unity of design and more permanence in sign selection moving forward will deliver more cohesive wayfinding over time. This will be most successful if the university takes on an active “weeding” program initially to eliminate the visual clutter and wayfinding confusion that exists today.

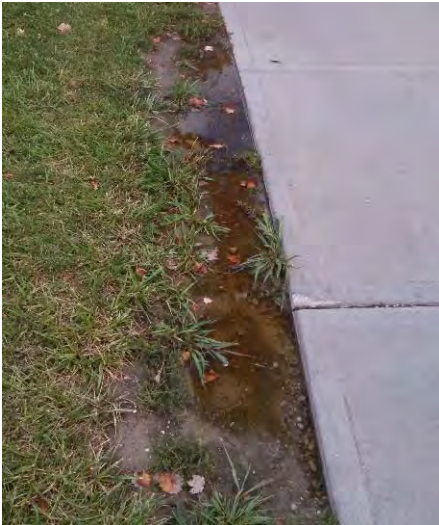
*Photo Number: 5*

*Location: Sidewalk*

*Description: Erosion along sidewalk from large amounts of surface drainage flowing toward Downs Drive*

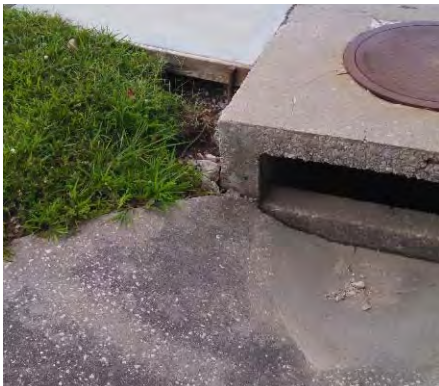
*Photo Number: 6*

*Location: Area Inlet*

*Description: Surface drainage under cutting sidewalk at area inlet.*

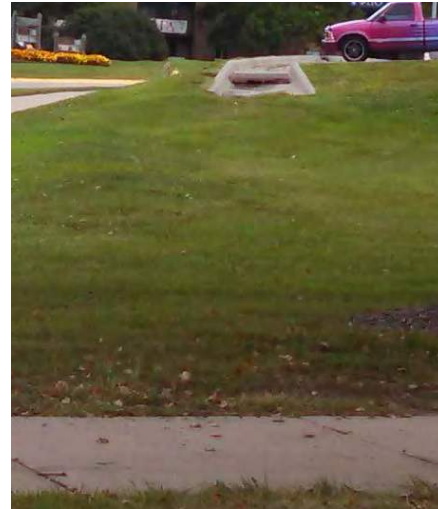
*Photo Number: 7*

*Location: Parking Lot G*

*Description: Erosion at end of concrete flume*

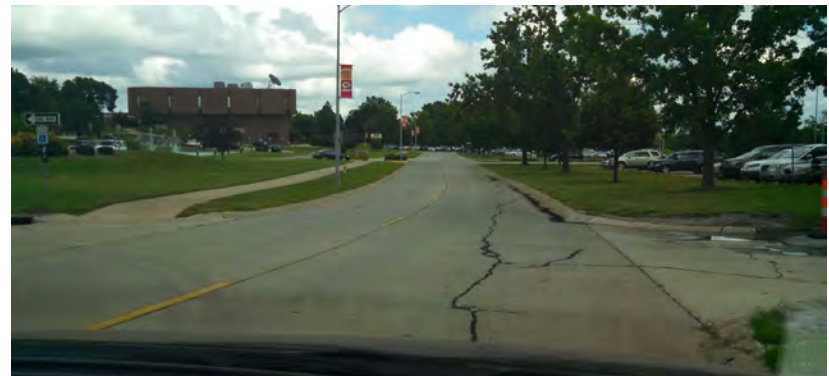
*Photo Number: 8*

*Location: Downs Drive*

*Description: Longitudinal crack*

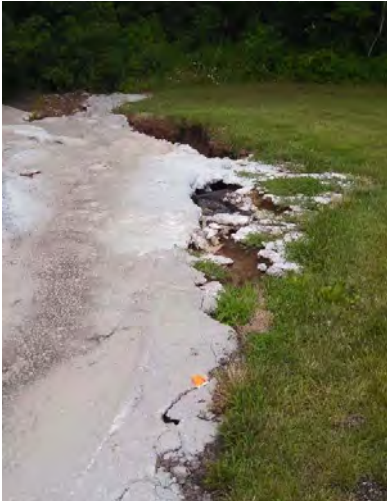
*Photo Number: 9*

*Location: Parking Lot O*

*Description: Major erosion around concrete at discharge location.*

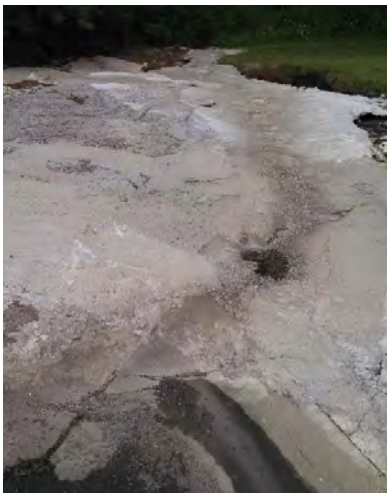
*Photo Number: 10*

*Location: Parking Lot O*

*Description: Major erosion around concrete at discharge location.*

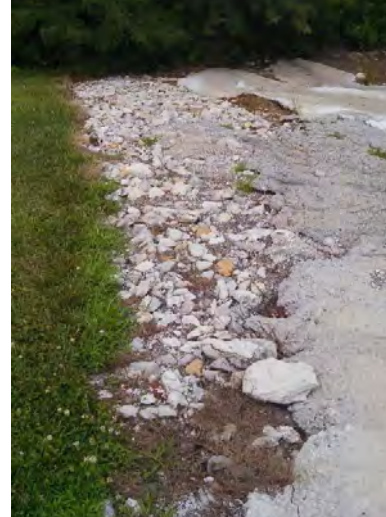
*Photo Number: 11*

*Location: Parking Lot O*

*Description: Major erosion around concrete discharge location*

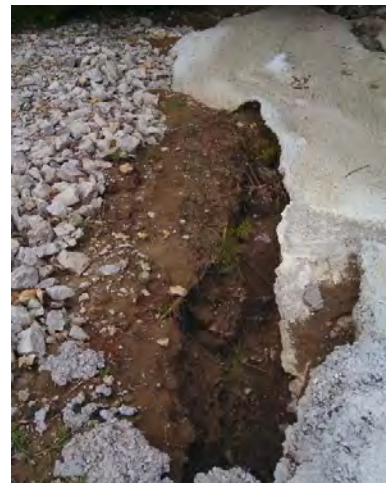
*Photo Number: 12*

*Location: Parking Lot O*

*Description: Major erosion around concrete discharge location*

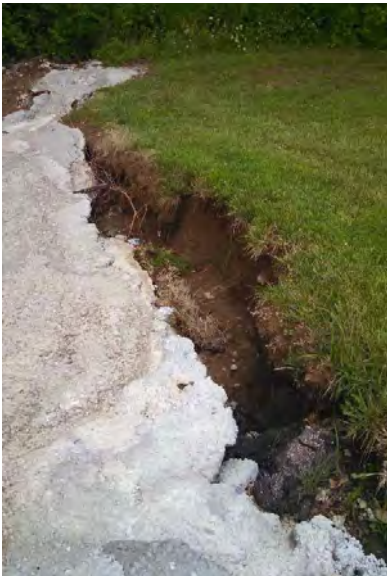
*Photo Number: 13*

*Location: Parking Lot O*

*Description: Major erosion around concrete discharge location*

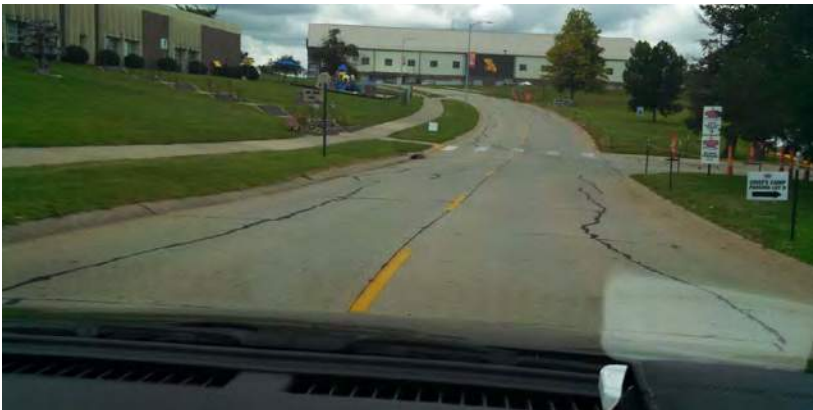
*Photo Number: 2*

*Location: Downs Drive*

*Description: Longitudinal crack in both lanes*

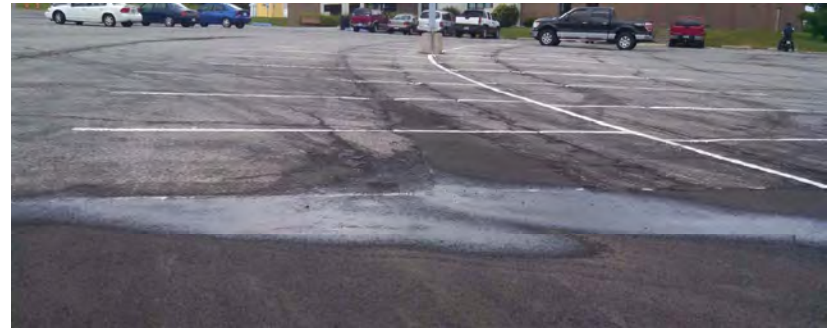
*Photo Number: 3*

*Location: Parking Lot H*

*Description: Water seeping through asphalt*

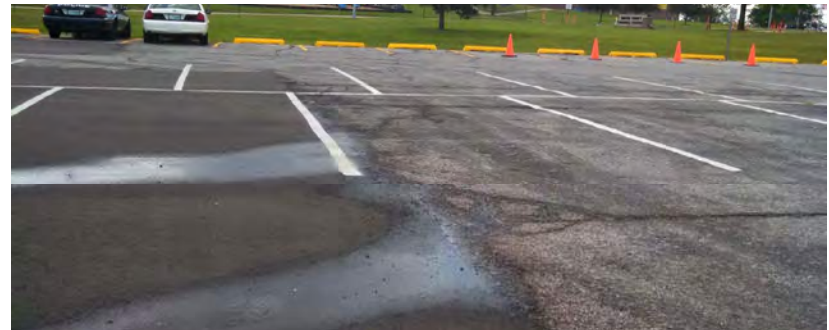
*Photo Number: 4*

*Location: Parking Lot H*

*Description: Water seeping through asphalt*

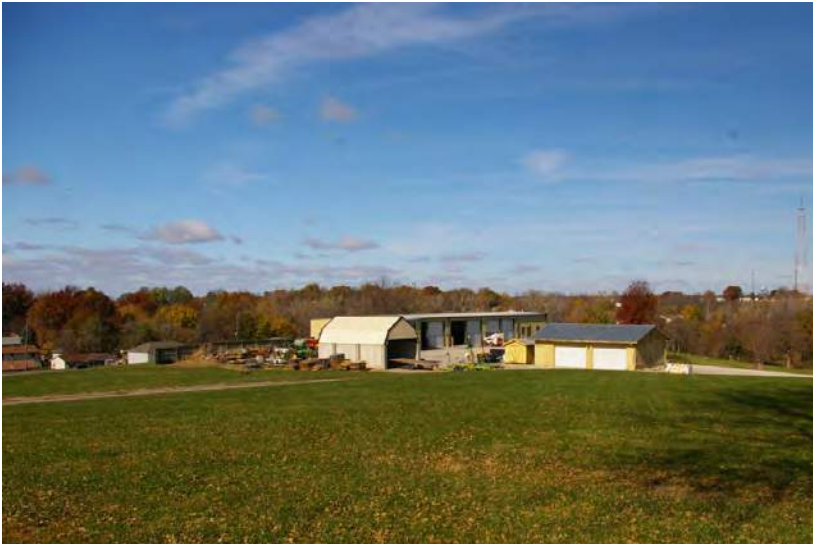
Figure 1: Example of fescue area that could be converted to hay, prairie, reduced mowing or no mowing.

One of the most obvious recommendations is to reduce the acreage of turf mowed, which can be accomplished by converting turf areas to prairie ecosystems which do not require frequent mowing, converting non-native turf areas to native turf that does not require frequent mowing (Figure 1), limiting mowing in some areas to parking lot and walkway edges (Figure 2), and converting turf areas to additional hay production (Figure 3).

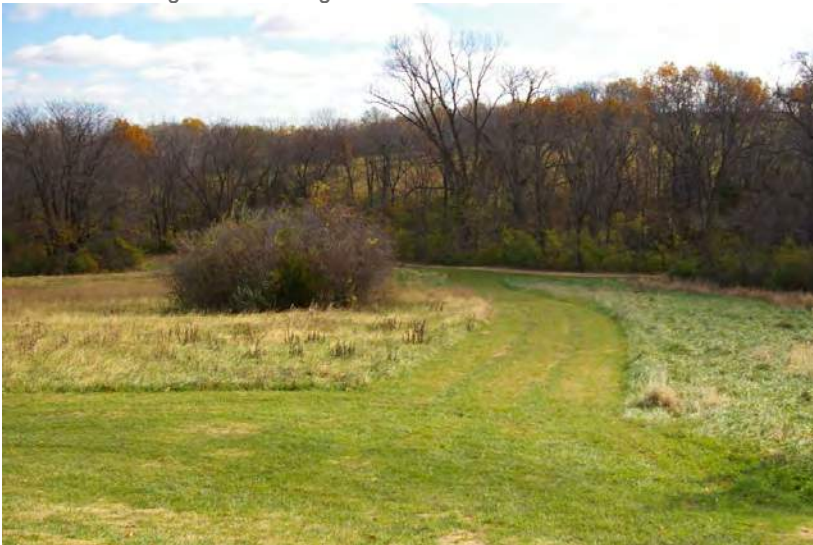
Figure 2: On-campus (northeast of stadium) example of a mown edge.

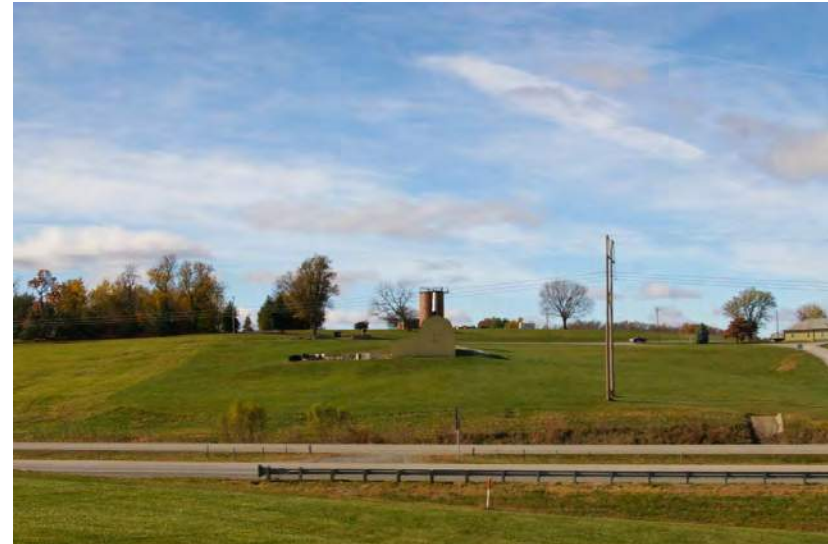
Figure 3: Potential hay area west of I-29.

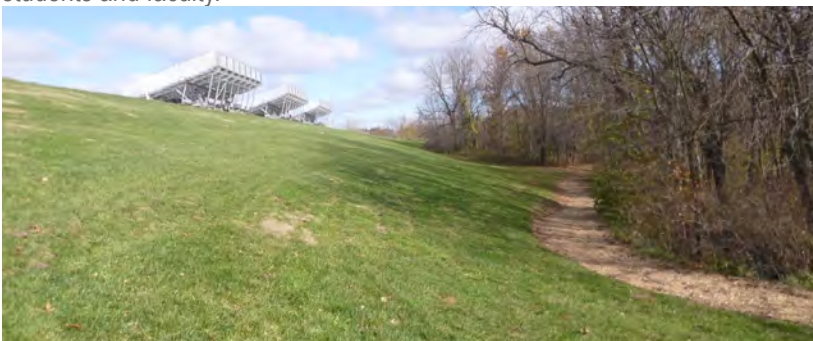
Figure 4: Steep mown slope behind stadium.

Other recommendations for reducing the acreage of mown turf include not mowing drainage swales or slopes (Figure 4), increasing the riparian corridor buffer a minimum of 50 feet (Figure 5), and adding buffer strips (10-foot minimum) at the perimeter of all ponds (Figure 6). Not only will these recommendations reduce labor and material costs but they will also reduce surface water pollution and should help deter the resident goose population.

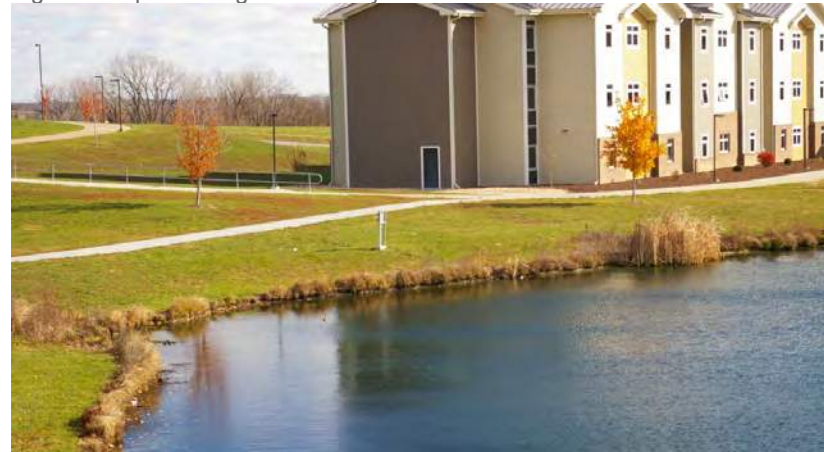
Figure 6: Mown pond edge by Griffin Hall.

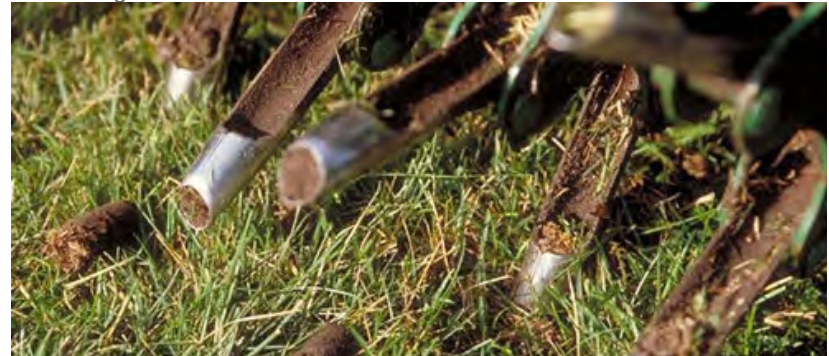
Figure 7: Aeration plugs.

Aerating at least once per year will reduce compaction and allow water, air and fertilizers to reach grass roots, thus improving turf health and reducing maintenance in the form of overseeding, watering, fertilizing, and weed management (Figure 7).

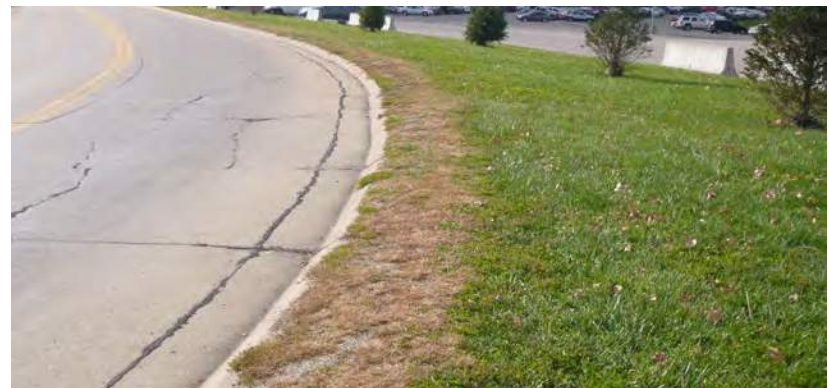
Figure 8: Turf damage caused by salt applications.

A consideration for de-icing may be the use of calcium chloride as a replacement for sand, rock salt or chat. Calcium chloride alone can reduce salt damage to the turf (Figure 8). Calcium chloride can also be mixed with rock salt to improve its effectiveness, although this will not reduce turf damage.

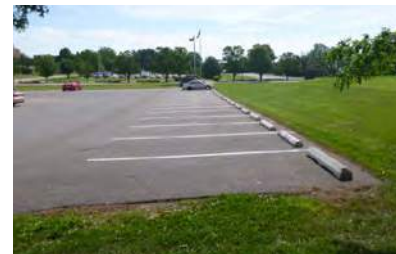
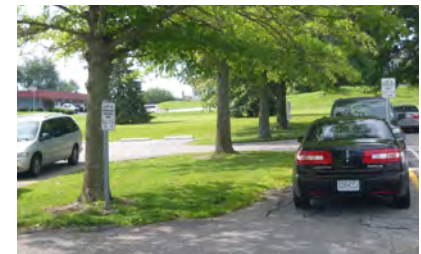
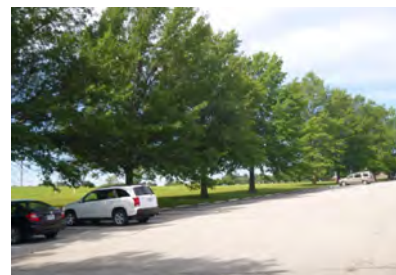
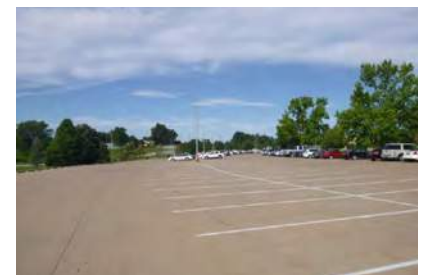
## Parking

Campus parking located mostly outside of internal loop road. Opportunity to introduce shade trees to unplanted areas. Some areas include deciduous shade trees such as Pin Oak, ash, Sugar Maple and pecan. Users prefer to park under or near shade trees where available, even if a walk to their destination is greater. Areas planted with shade trees are also much more attractive and reduce the heat island effect.

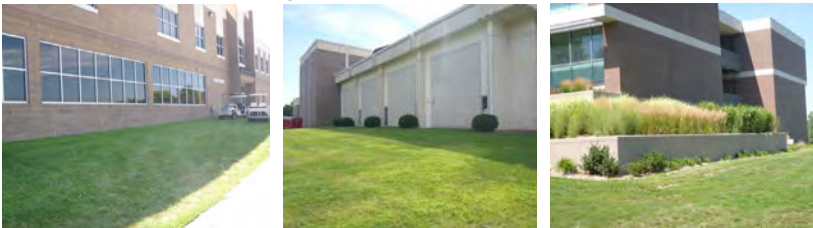
## Building - Facades

Building facades not including entry and exit points. Treatment ranges from turf only to plants widely spaced around building perimeters to an intensive use of deciduous and evergreen shrubs, perennials and annuals.

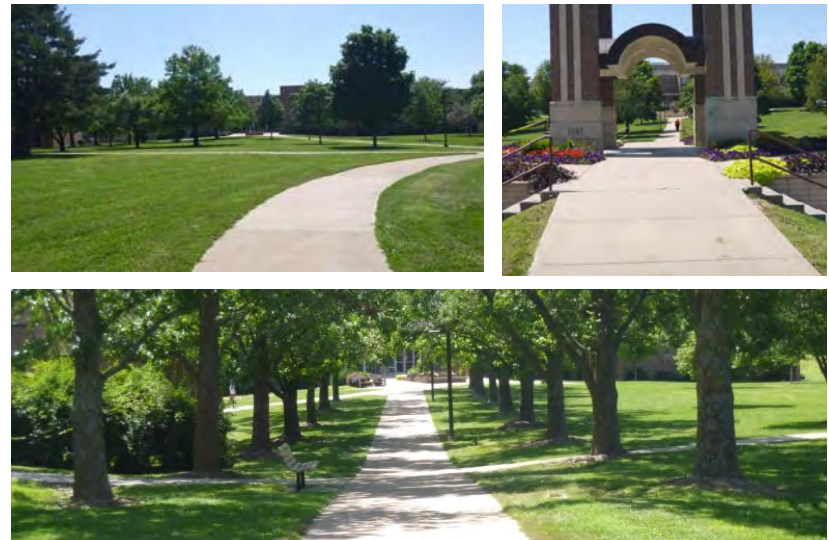
## Green Spine

Heart of campus within loop road and academic halls. Landscape ranges from turf only to allées of deciduous shade trees including Sweet Gum, European Linden, Green Ash, Sugar Maple, White Pine, Spruce, crabapple, River Birch and mimosa. Glenn E. Marion Memorial Clock Tower is nicely accentuated within evergreen shrubs, perennials and annuals.

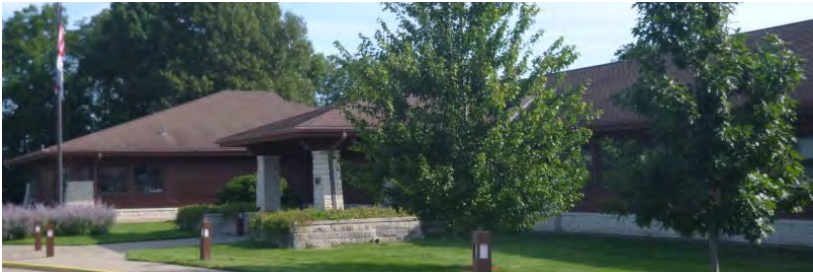
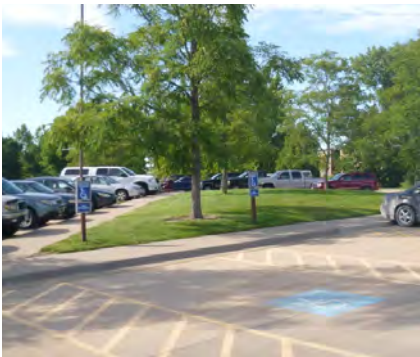
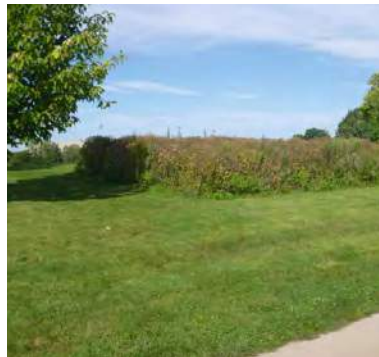
## Missouri Department of Conservation

MDC property located off of James McCarthy Drive, north of student housing. Nicely planted sign, building entry and parking lot consisting of deciduous and evergreen trees, shrubs, and perennials. Species include European Linden, Northern Red Oak, Red Maple, Sugar Maple, and sycamore. A mass of native grasses and forbs also exists near the entry including bee balm and coneflower.

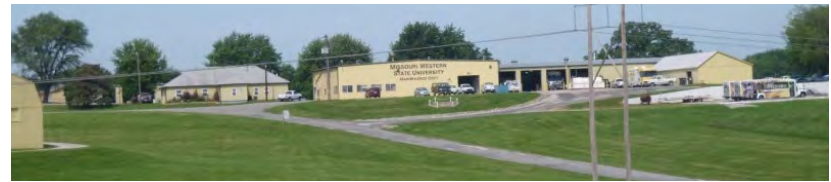
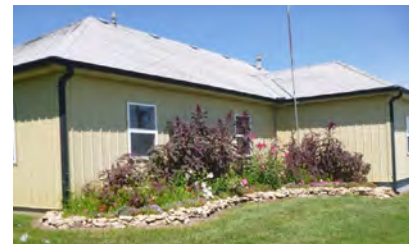
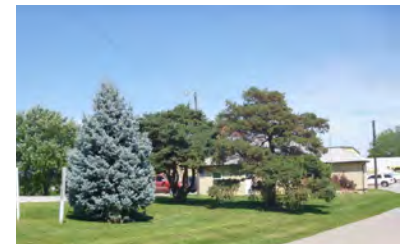
## Support Areas

Maintenance complex and Extension office west of I-29. Mostly open landscape (turf only) except for deciduous and evergreen trees naturally spaced throughout. Accent plantings can be found adjacent to Physical Plant Office. Residence south of Extension office is attractively planted with deciduous and evergreen shade trees, shrubs, and perennials. Species include pine, spruce, European Linden, elm, Black Walnut and oak.

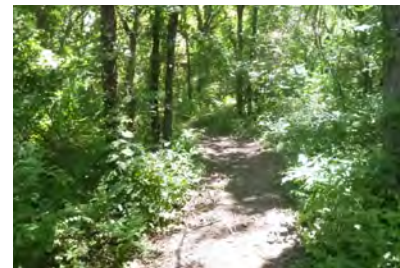
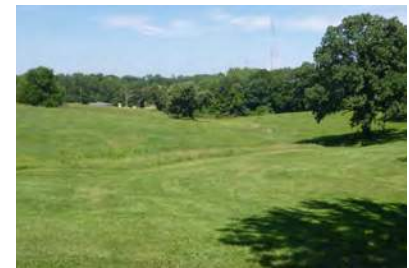
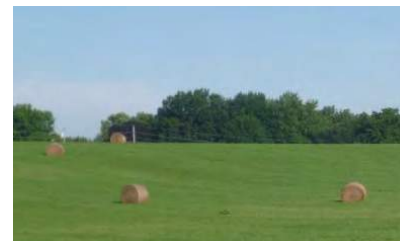
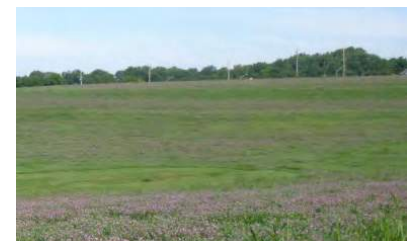
## Undeveloped Areas

Areas throughout campus that have not been developed for use by the university. Landscapes include hay production to the north, east and west consisting of cool season grasses and invasive Johnson Grass. Heavily wooded areas exist north of the main campus including the Otoe Creek Nature Area. Woodland species include Black Walnut, cottonwood, mulberry, hickory, oak, elm, Black Willow, shrub or bush honeysuckle and a mixed understory. Opportunity to reduce mowing if desired.

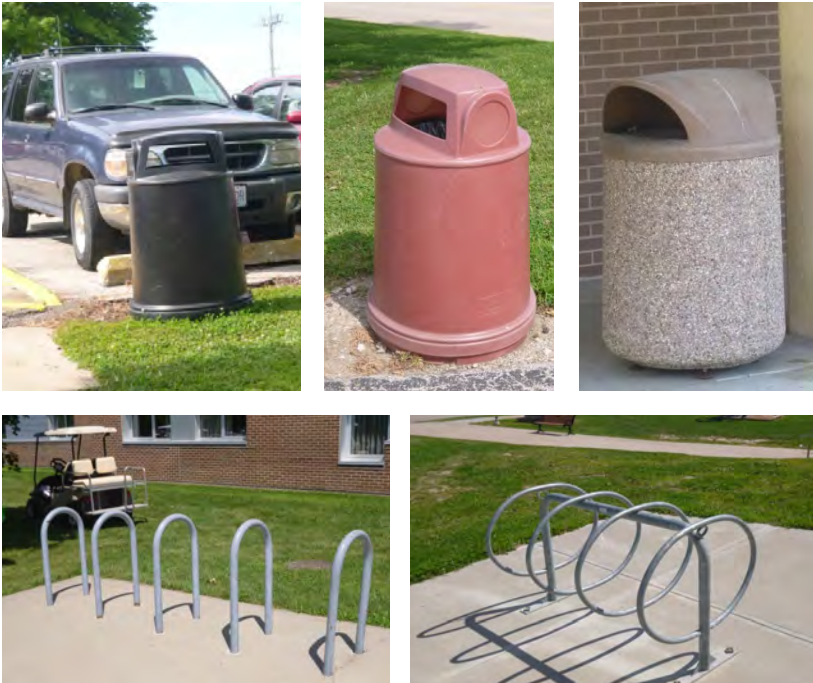
## Site Furnishings

Furnishings located throughout campus: benches, trash receptacles, bike racks, planters, etc. Good opportunity to unify site furnishings in style or color.

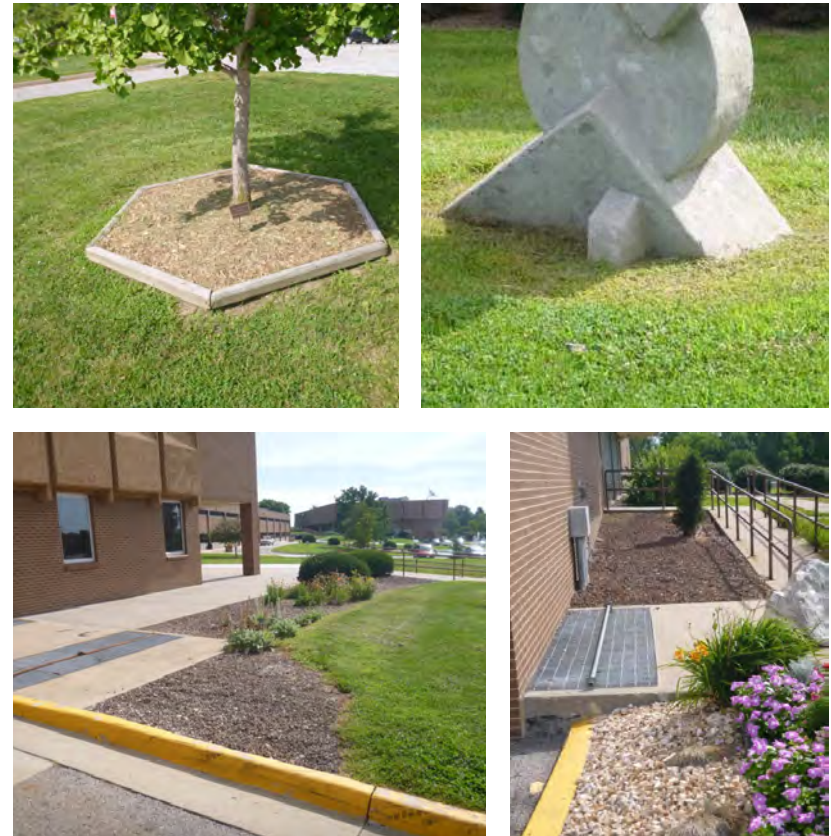
## Other

Various landscape treatments located throughout campus. Opportunity to unify mulch treatments, reduce maintenance at sculptures, and refine planting beds.

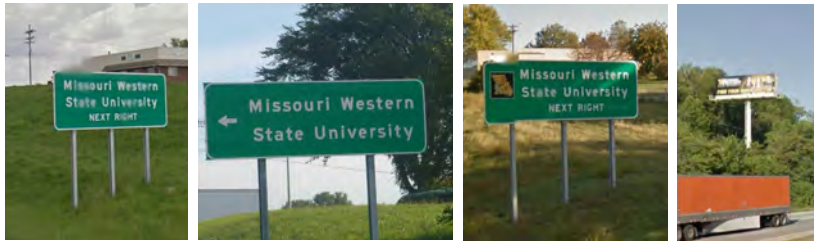
## Feeder

These signs are off campus and direct vehicular traffic from regional highways to the university. Currently located on I-29, US Route 36 and Riverside Road.

Except for custom billboard graphics these aluminum sign panels, with and without the MWSU logo, would require coordination with MoDOT.

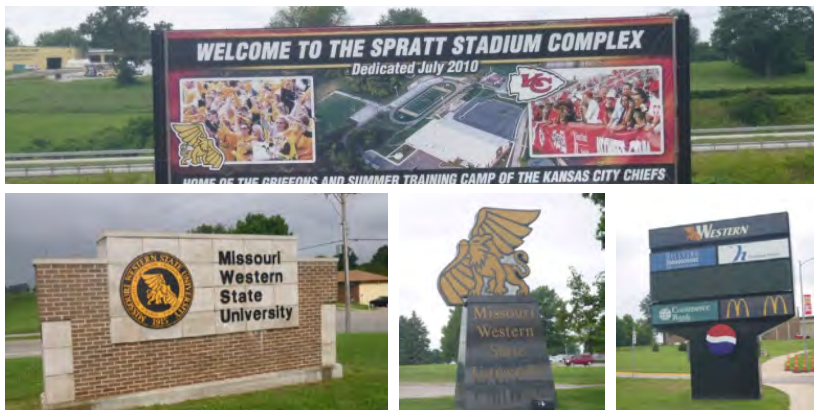
## Campus Identity

These are monument signs that identify the University from adjacent roadways. Located on Mitchell Avenue, Faraon Street, and Downs Drive.

A variety of styles, materials and colors. Newer brick signs match existing brick buildings but may not fit brand. Text on Mitchell Avenue sign is somewhat hard to read due to level of contrast. Text styles vary too.

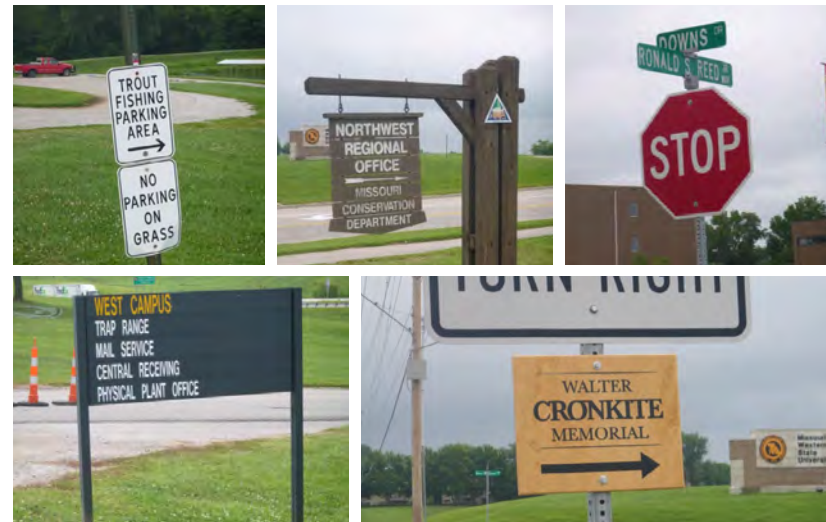
## Vehicular Wayfinding

These signs direct vehicles to various facilities and should be located throughout campus.

Signs vary in style, materials and colors. Some are very utilitarian. Text styles vary. MDC sign, although rustic, is the department's brand on Missouri Western's campus. Possibly too few of this family.

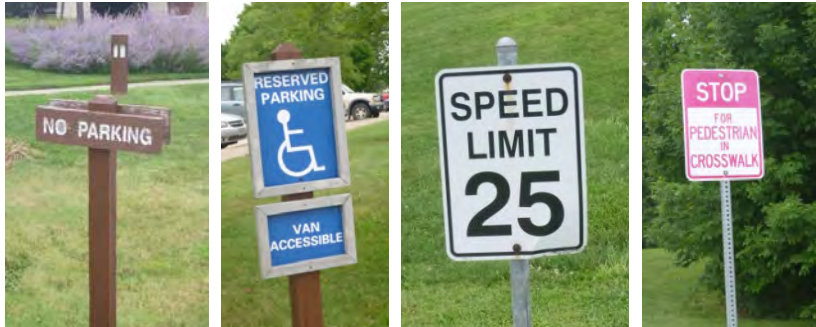
## Traffic Regulatory

These signs provide regulations for vehicular traffic and are located throughout campus.

Signs of this nature are “off-the-shelf” as standardized by the Manual on Uniform Traffic Control Devices (MUTCD) and can be placed into an overall signage package.

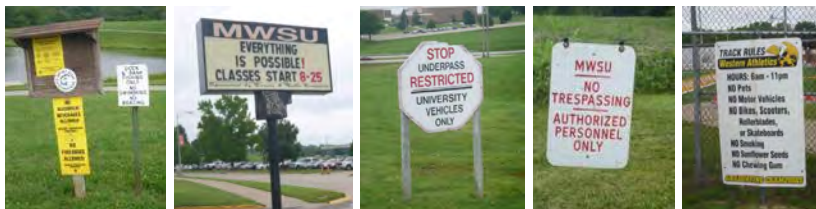
## Regulatory / Informational

These signs provide regulations and information for vehicles and pedestrians and are located throughout campus.

Signs vary in style, materials and colors. Very utilitarian with just rows of text. None of them seem to promote the character of campus.

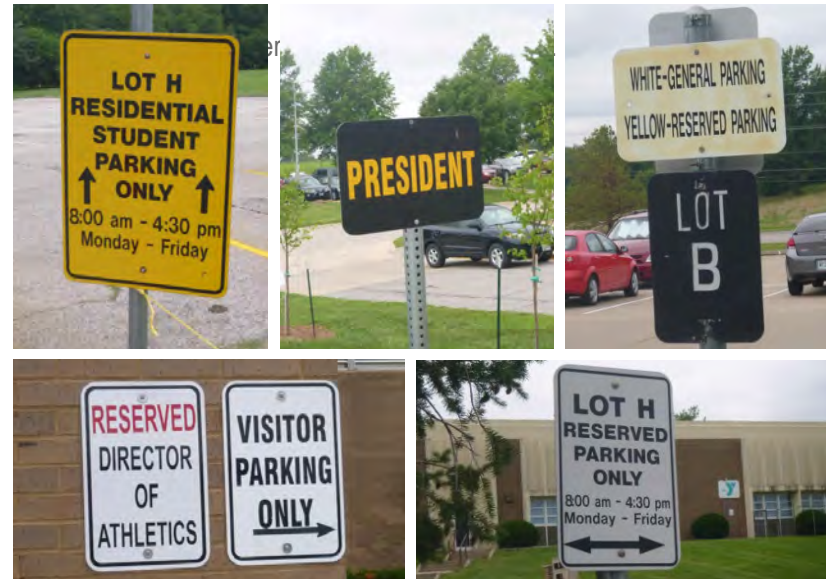
## Regulatory / Informational - Parking

Located throughout campus, these signs provide regulations for vehicles other than those standardized by MUTCD.

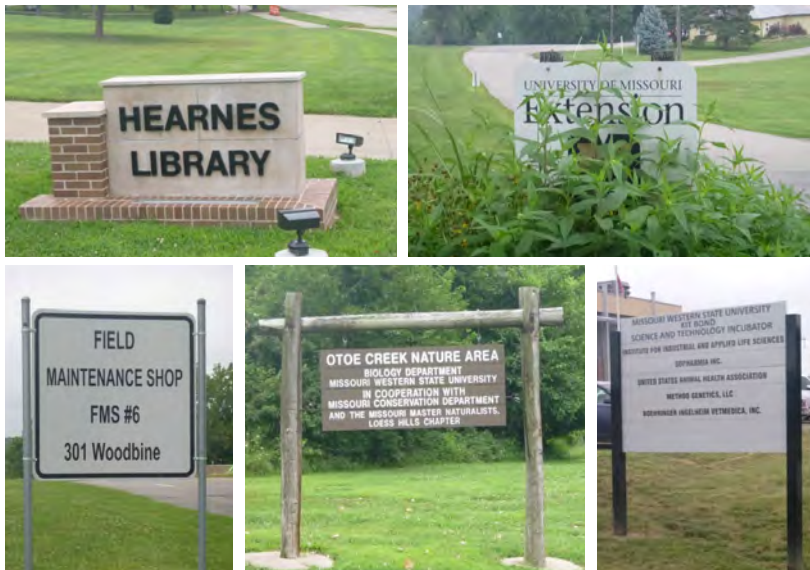
## Facility Identity - Freestanding Signage

These signs identify each facility or primary feature on campus and are typically located adjacent to the facility or feature for visibility by both vehicles and pedestrians.

Signs vary in style, materials and colors. Text styles vary. Some do not convey the “brand” of MWSU. Many of the newer brick signs are a clean and legible sign family.

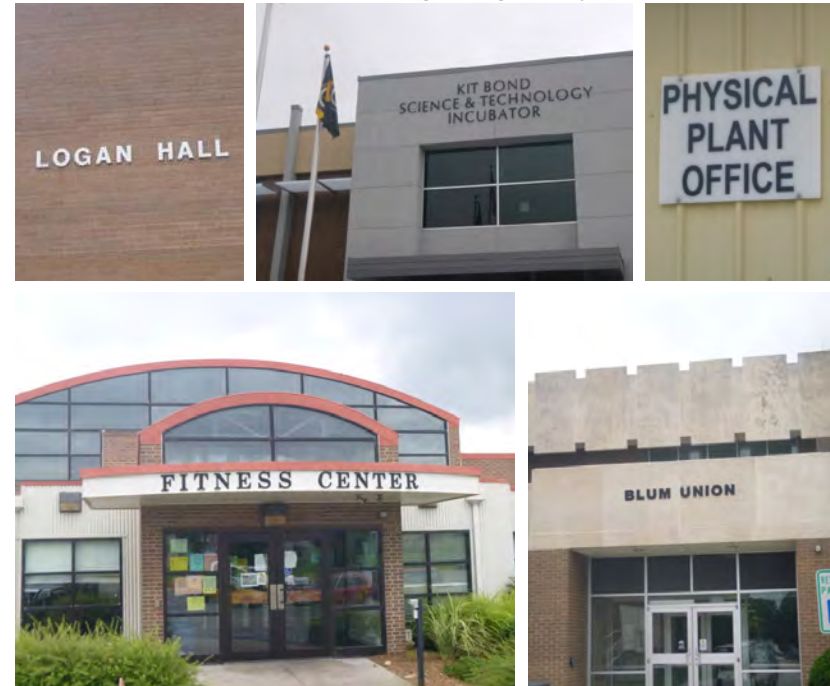
## Facility Identity - Building Mounted

These signs identify each facility or primary feature on campus and are attached to the facility or feature for visibility by both vehicles and pedestrians.

Signs vary in style, materials and colors. Text styles vary. Many of the letters located on the halls are a clean and legible sign family.

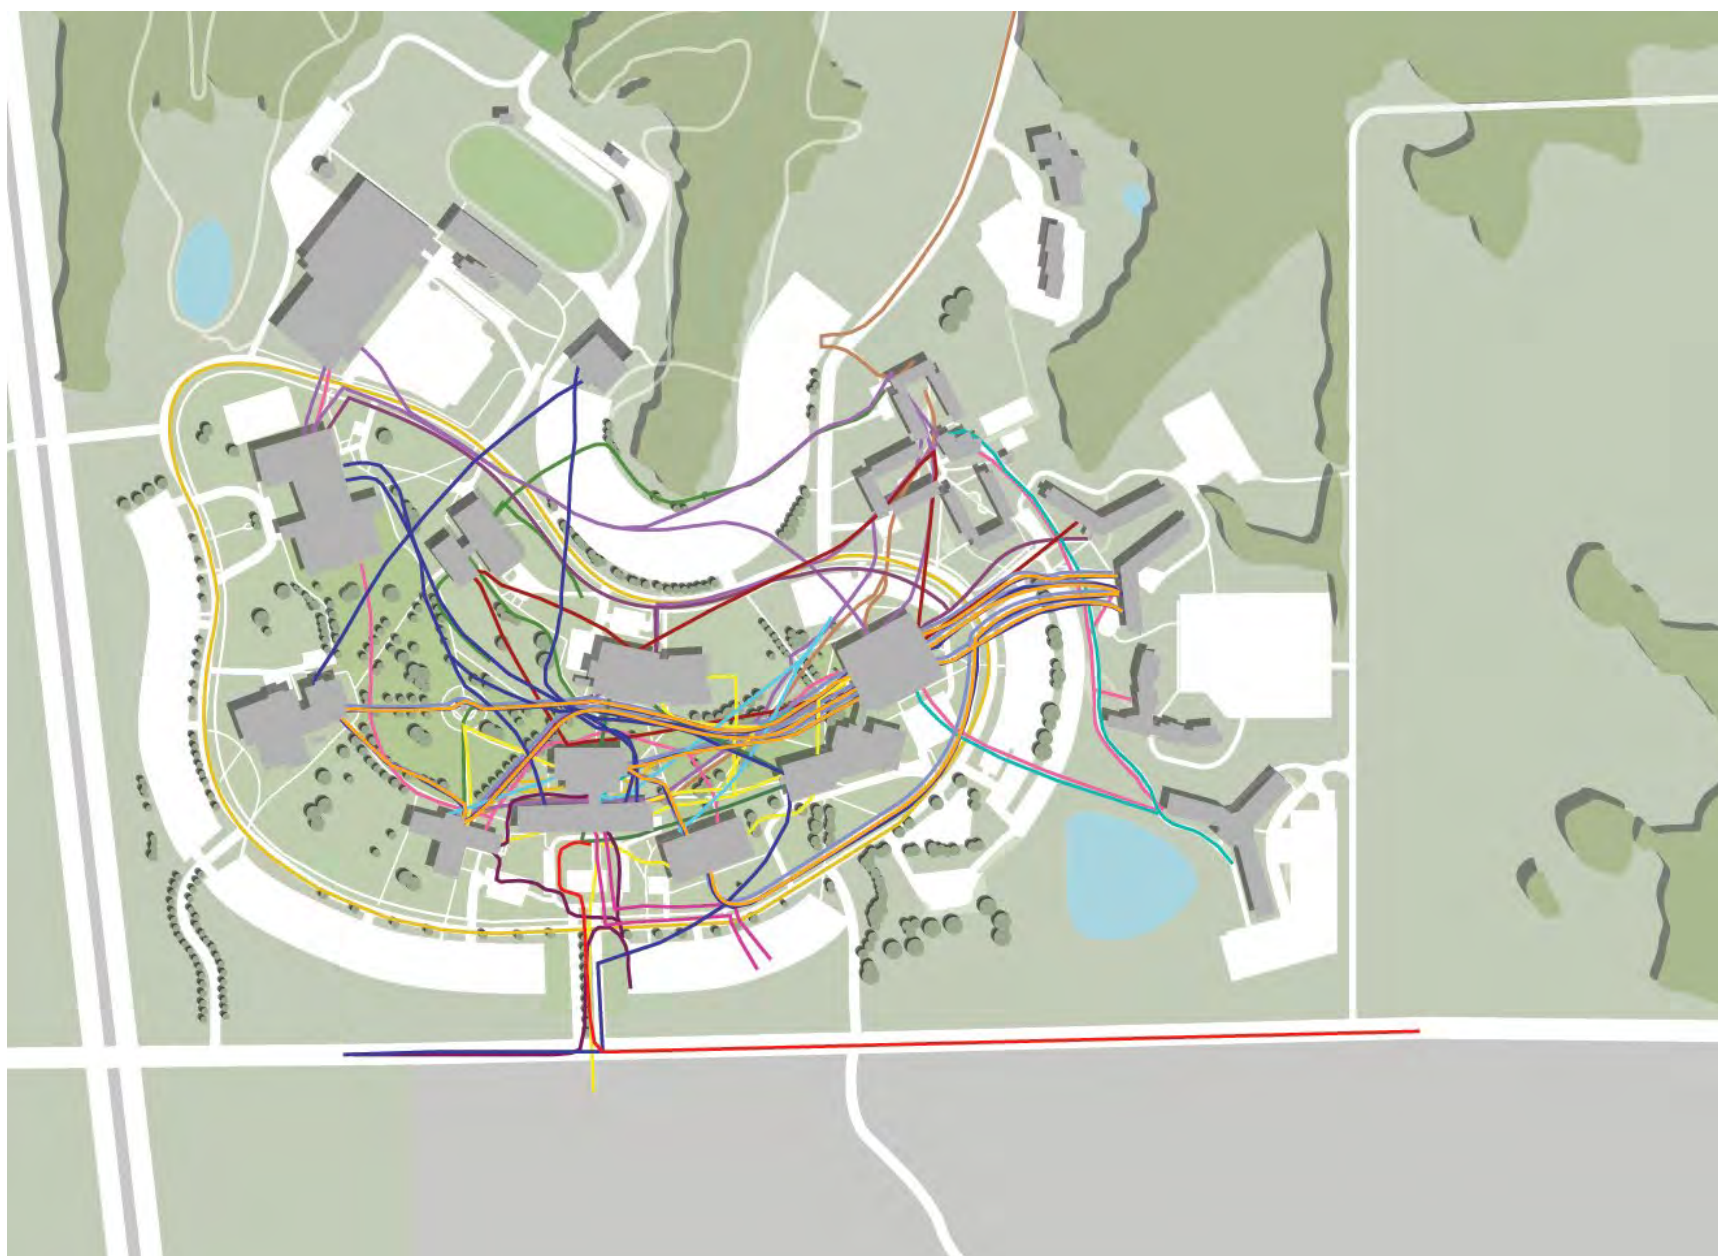
Through collaboration with student government and the master planning team, a group of students mapped their daily route across campus to inform and clarify the impressions of university stakeholders as to how pedestrian and vehicular circulation occurs on campus.
